UCO/Lick APF

IceStorm Enclosure (Series 2)

Lick APF Site Inspection Report

6 June 2007

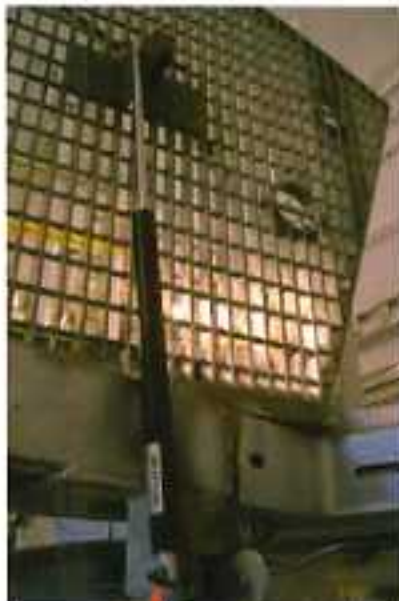
It is agreed this is not an adequate fix and potential for serious injury increased, due to insufficient force applied by the single strut preventing the hatch from falling. It has also meant that strut pins may have fatigued as they are “working” twice as hard.

Single strut and fatigued pin

A site inspection prompted Jason Chapman to advise UCO-lick to lock the hatches in a safe position until appropriate remedy is applied. The second gas strut was re-installed to the heaviest hatch piece and the hatch became workable.

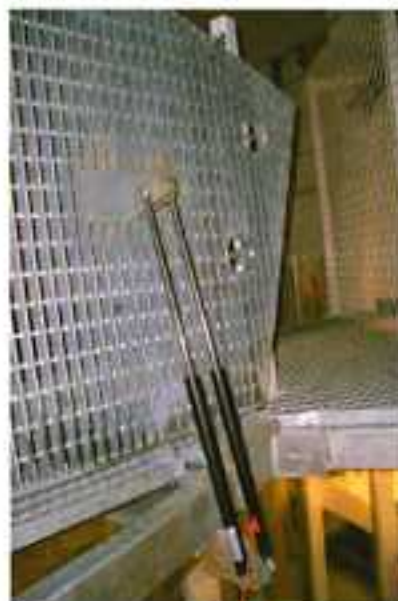
Second Strut re-installed

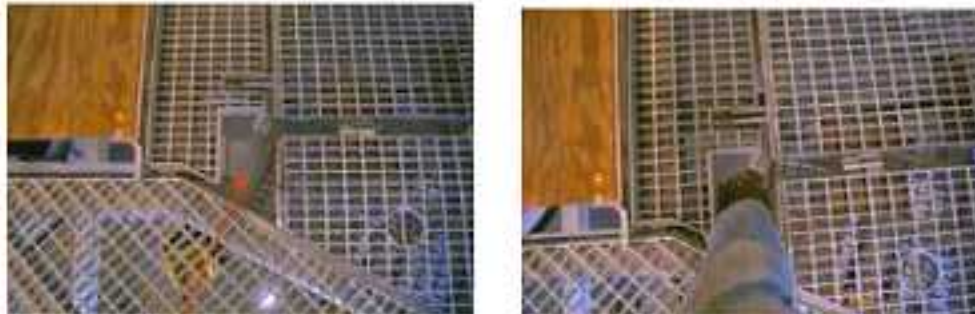
Figure 4 Void in floor, EOS are asking UCO to fill.

UCO-Lick identified a void in the level 3 floor adjacent to the hatch. The void has the potential to be a trip hazard.

During assembly of the enclosure, EOS provided an infill piece to fill the void, which was caused by hatch modifications. The piece was small and was not located on site when Jason Chapman inspected the enclosure in May 2007.

Void in L3 floor

UCO should find or make and install this part to eliminate the trip hazard.

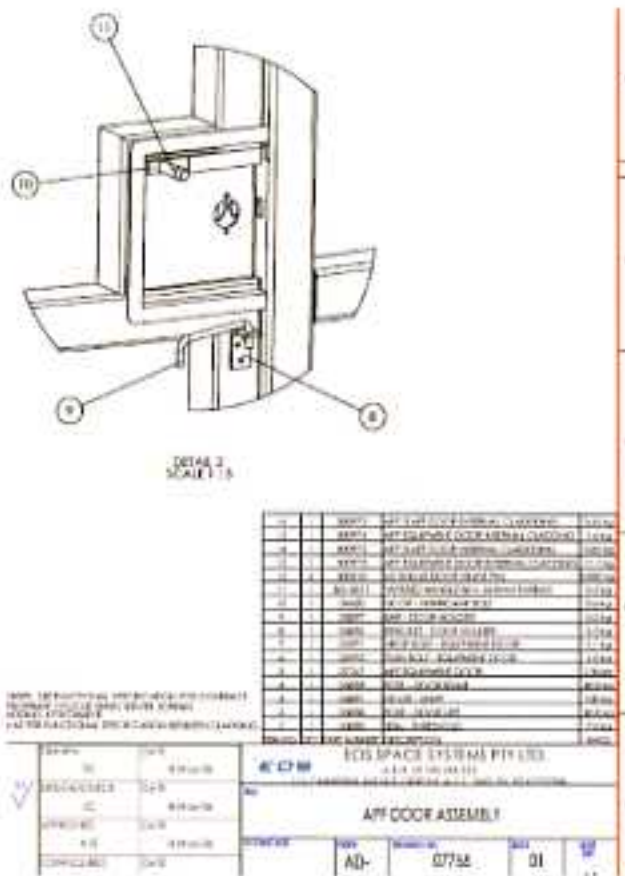
Figure 5 Exert from door drawing – Calls out dead bolt as “Door Hurricane Bolt”

UCO-Lick claimed a safety hazard was imposed by the exterior deadbolt system on the staff entry door. The claim was made that someone could be trapped inside the enclosure if the bolt was utilised. UCO-Lick appeared to be under the impression the deadbolt was temporary.

The deadbolt existed as a precautionary lock during extreme survival conditions, to avoid the door latch being the only part preventing the staff door from being sucked open. The deadbolt has always been part of an IceStorm design, it is present at the Mt Stromlo facility and appeared on design review models.

EOS does not consider this as a design flaw or safety risk and proposes no further action is required. However, for the abundance of caution, if UCO-Lick deem this to be an unacceptable risk, then we propose to cut off the deadbolt tang to render the deadbolt inoperable.

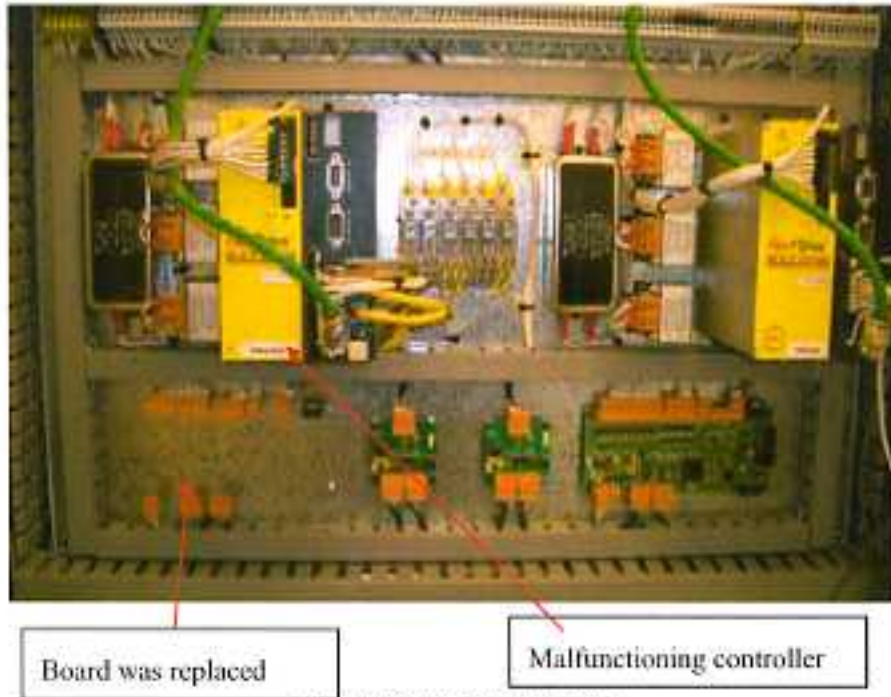
Figure 6 Shutter control panel

UCO tried to operate the front shutter after a period of high rainfall. The shutter would not operate and a preliminary investigation showed potential damage to a printed circuit board directly linked to front shutter operation.

The printed circuit board was replaced on site by Jason Chapman and the replacement proved to have communications with the appropriate parts of the control systems, however the shutter was still not operational.

Further investigation by Jason Chapman and Steve Vogt indicated that the front shutter controller / amplifier was not communicating with the rest of the control systems. After a phone conversation with the EOS electrical group the decision was made to remove the amplifier and return it to Australia for assessment.

The control cabinet has obvious signs of water ingress, which seems the most likely cause of shutter parts malfunction or failure. The water has apparently made its way into the control cabinet from upper levels of the enclosure. During installation, EOS installed expansion foam on the top of the cabinet to control moisture ingress (water and humidity) to the control cabinets. On inspection this was no longer present.

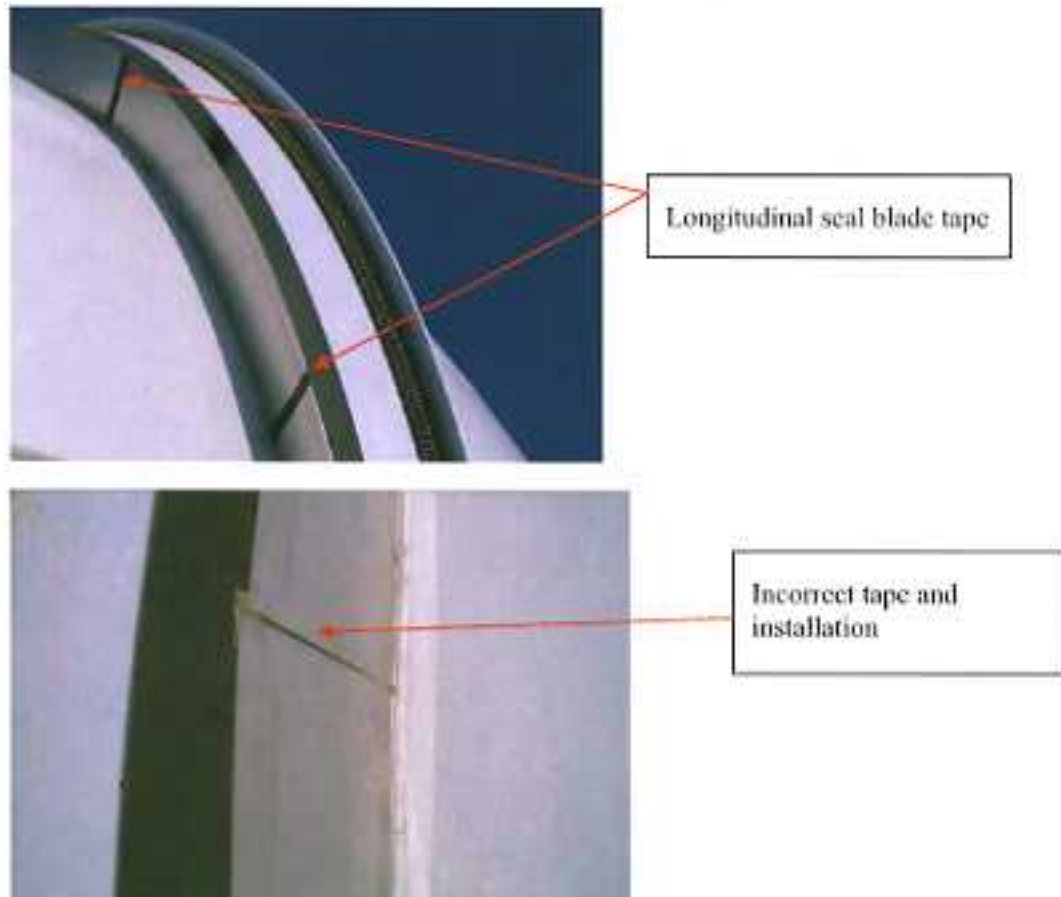
Figure 7 Longitudinal seal blade tape, preventing seal flap snags on blade ends.

UCO noted that a tape installed on the longitudinal seal blade was falling away.

Further investigation by Jason Chapman and Matt Radovan showed the tape on the seal blade was not the correct tape specified by EOS. It was also noted that it was installed in incorrect positions and was probably installed on stainless steel blades that were not cleaned sufficiently prior to installation of the tape.

Temporary tape had been installed during shutter frame alignment. The final to-be-installed tape was issued and was to be re-installed by WPY after shutter alignment work was complete.

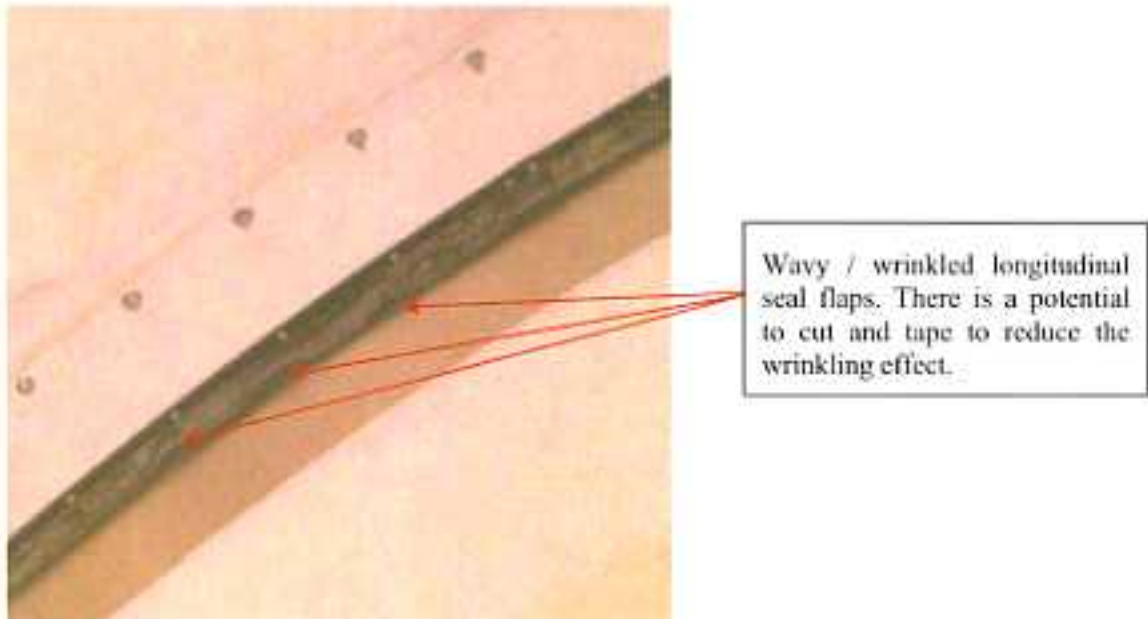
Figure 8 Longitudinal seal flaps.

UCO-Lick has stated that the shutter longitudinal seals flaps are not sealing appropriately due to wrinkling.

These longitudinal seal flaps are installed to prevent significant light leaks and to minimise air flow between the exterior atmosphere and the enclosure interior. No light leaks were observable along these seal flaps. It is not easily determined if the seal flaps would improve air leakage significantly if they had 100% contact along their length.

As no moisture is infiltrating at these points EOS has determined the seal positions and function as acceptable, and replacement of the seals is not necessary.

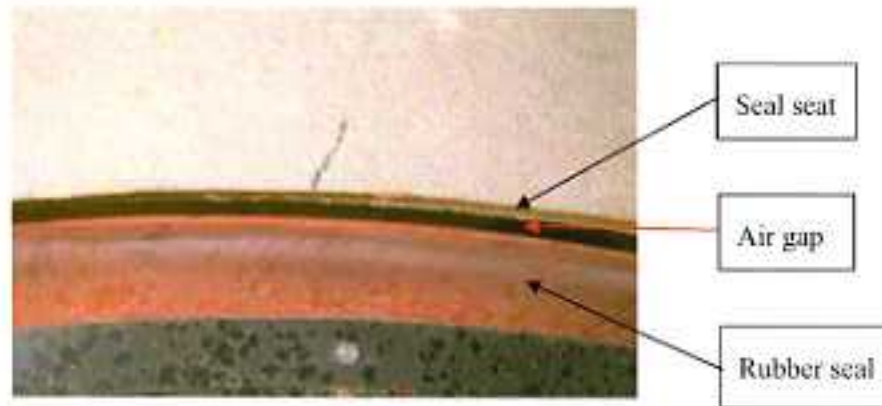
UCO-Lick observed a source of light leak from Level 1 to Level 2 during night hours, when Level 1 lights are switched on and the observing space is in darkness. The leak was traced to the seal that runs around the telescope base.

It appeared that there is a significant gap were the silicone rubber seal flap should run on a stainless steel pier seal seat.

Figure 9 Air gap present in pier seal.

The problem appears to stem from straight strips of rubber being bent on a tight radius to form the seal flap. The radius is seemingly too tight and the rubber folds back on itself without touching the seal seat.

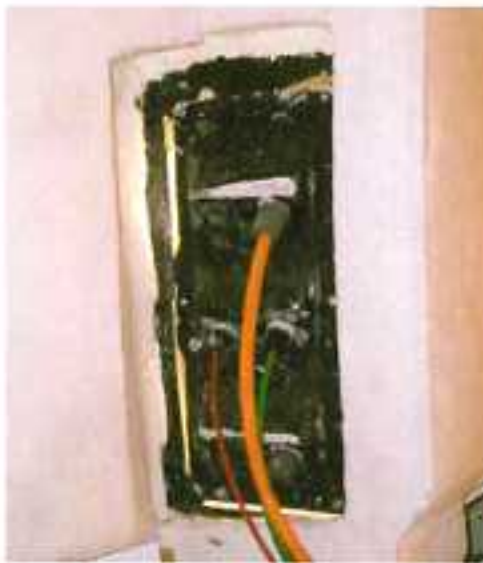
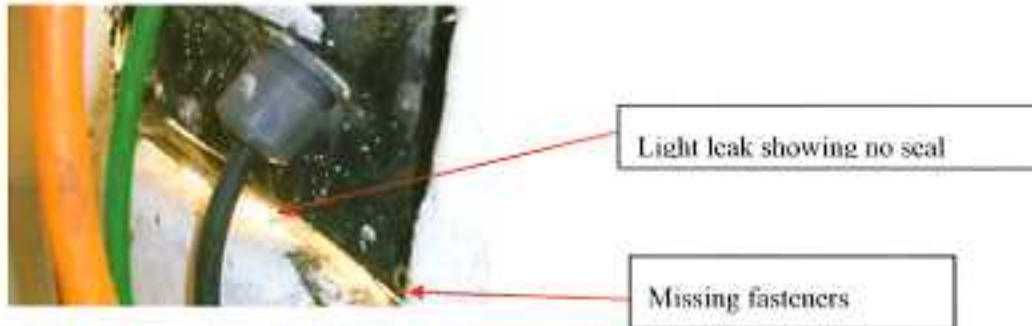
Figure 10 Shutter cable entry bulkhead / panel

UCO-Lick expressed dissatisfaction with the installation method of the shutter cables entry bulkhead, located on the inside of the troughs. There is no evidence of seal gaskets and 2/3rds of the attachment studs are missing nuts.

This was observed as being a valid assessment by Jason Chapman. Light leaks were prevalent around the bulkhead.

EOS will fabricate and deliver 2 x closed cell foam gaskets and a bag of fasteners to UCO Lick for installation onto the gland plate.

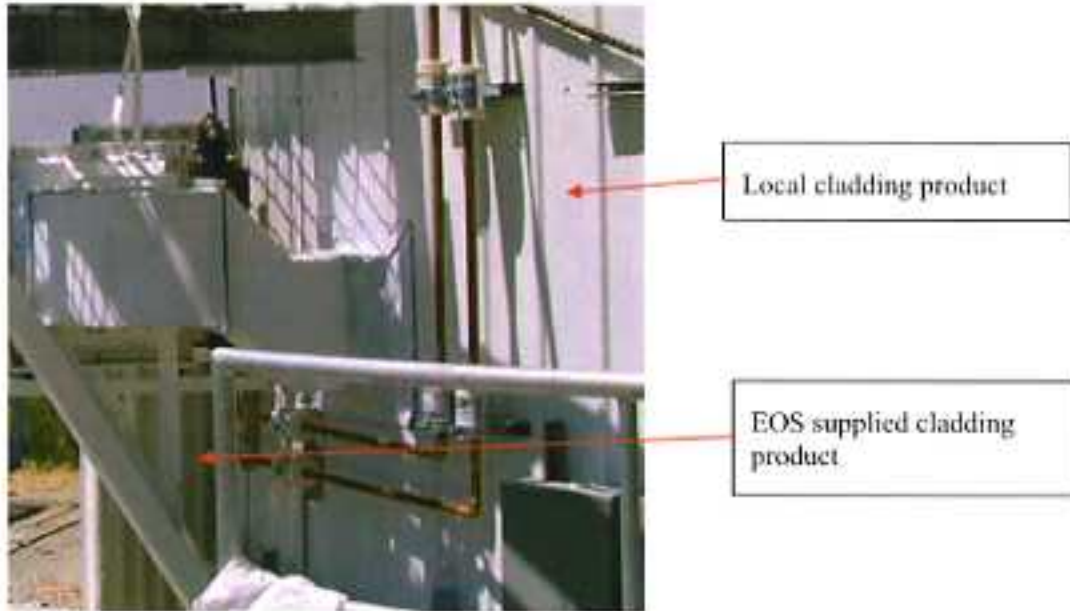
UCO-Lick noted that during the assembly there were problems with steel ring wall cladding supply. Locally sourced cladding was required to finish the enclosure.

EOS does not consider the cladding profile difference to be a function, design or other issue and in fact enhances safety as it acts as a tactile indicator of reaching the door when lights are extinguished in the enclosure.

Figure 11 Different cladding on the entrance door and ring wall.

The cladding on the door has been sealed with closed cell foam that conforms to the EOS supplied cladding profile. The advantages of keeping the supplied cladding profile outweigh any visual effect from replacing it.

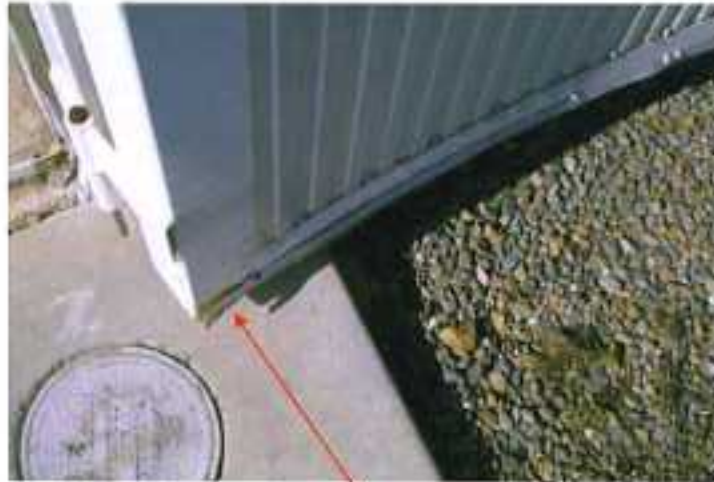
Figure 12 Entrance door weather seal

UCO-Lick pointed out a claimed deficiency in weather proofing the front entrance door. The claim was that seal material around the door jam is not sticking and the seal was inefficient.

The seal design is based on compression of closed cell foam between the door frame and the door jam or weather strips.

This Weather seal is claimed as inadequate for the intended task.

Seal style design will not change if no proof of normal weather conditions (wind blown rain other than extreme unusual force winds) causing leaks around the door can be demonstrated or recorded. If normal, as expected weather, can not infiltrate the entrance door seals the seal is regarded by EOS as fit for purpose.

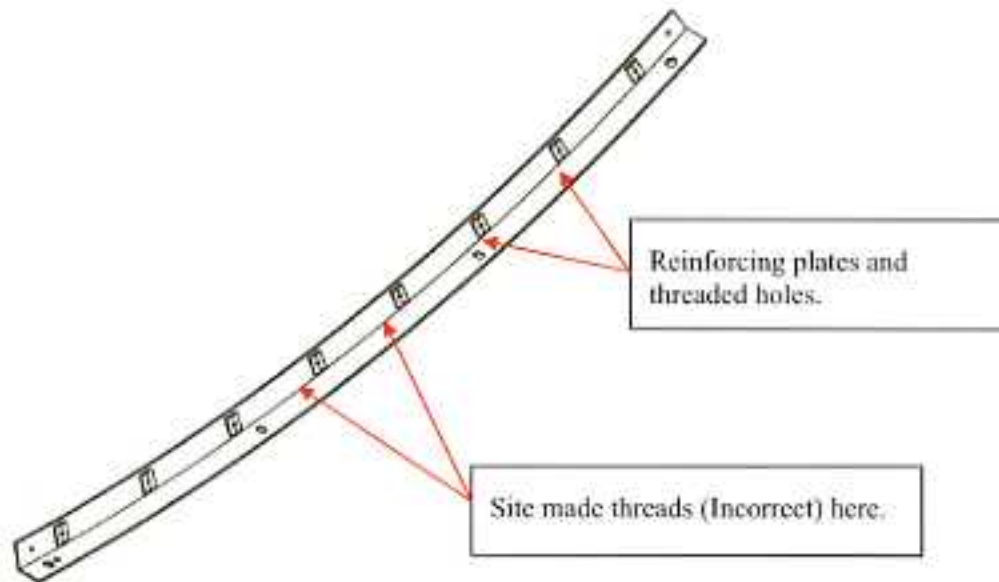
Figure 13 Shutter rail - Shutter flares installed to these

UCO-Lick claimed that an EOS representative, Mark Elphick, installed the flares in this manner. Ultimately WPY ought to have installed these parts.

UCO-Lick would like assurances that the incorrect installation still meets survival conditions.

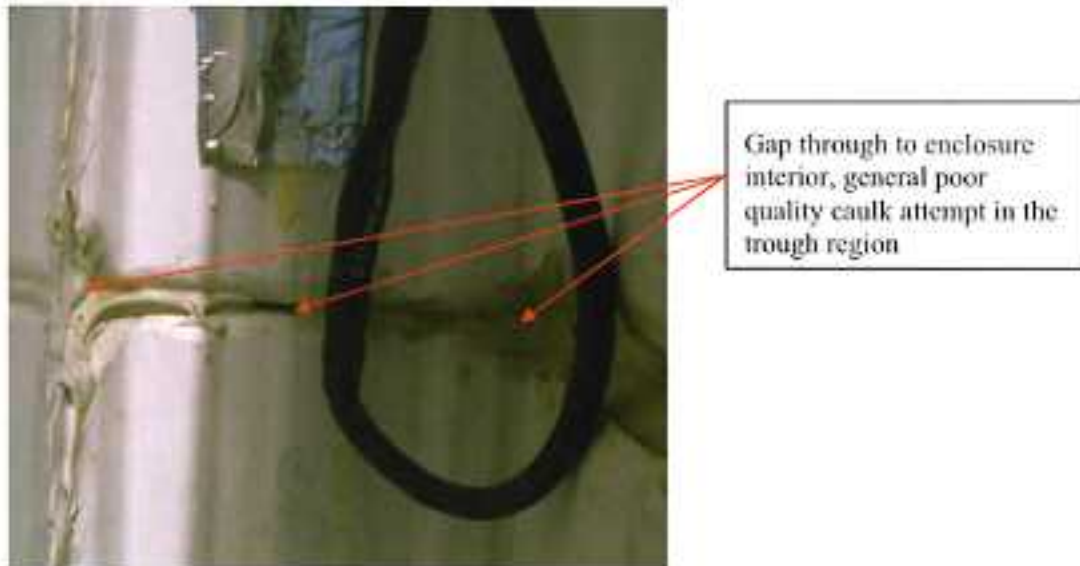
Figure 14 General example of trough sealing quality

Large pockets and gaps were easily distinguishable in most of the joints reviewed. All of these flaws would cause serious leaks, especially as the troughs act as a gutter during periods of precipitation. High flows of water would be prevalent in these areas.

The joints were also inspected by WPY. Matt Beaver, the WPY foreman during assembly, agreed that the workmanship was extremely poor and that it would in fact be possible to seal the troughs.

EOS will provide a procedure to re-caulk the enclosure infills and troughs, which will attempt to eliminate the need to remove the shutters from the enclosure.

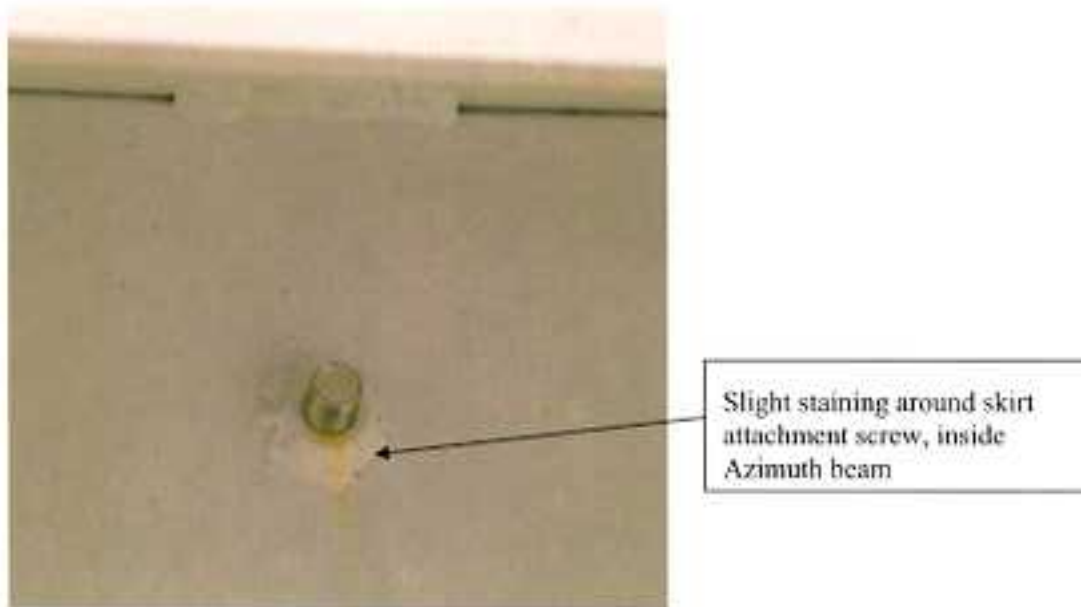
Figure 15 Skirt attachment screw

UCO-Lick incorrectly identified leaks as originating from the Vent Door Lower Rail Bolt Heads. Some slight discoloration is shown in the inside of the skirt attachment screws, inside the Azimuth support beam.

This discoloration is slight and Jason Chapman could not see any evidence of significant leaks, the discoloration may be caused by condensation after assembly, when the enclosure was still open to the elements. The position of the screws suggests it would be very difficult for water to make its way inside the enclosure from these points.

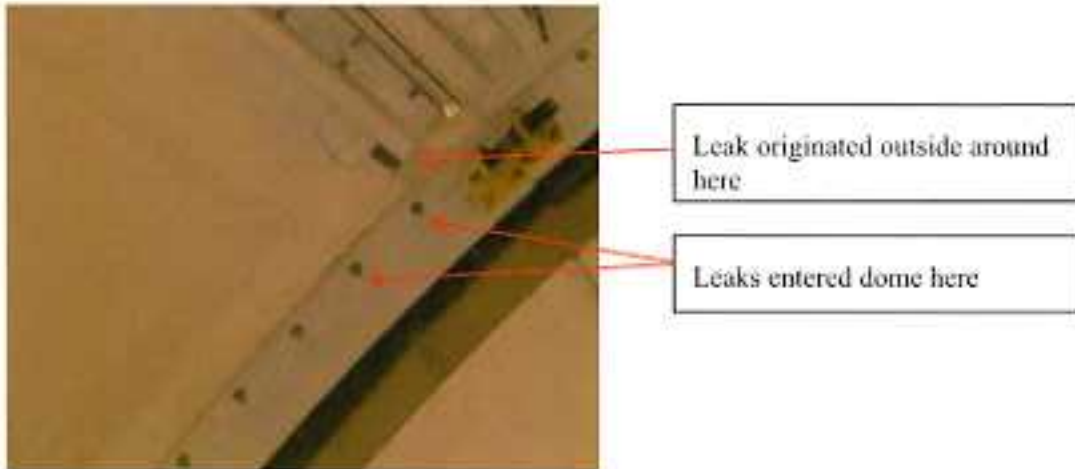
Figure 16 Shutter bolt leak

UCO-Lick found water dripping from 2 bolts on the upper right hand side of the front shutter, after a period of rain. An *assumption* was made that water had made its way into the enclosure via flare attachment points.

After investigation and suggestions by Jason to pour water on the shutter transverse gutter, the leak point was identified as a hole in the caulking, under the upper right hand side of the top transverse beam. Water channelled between an interior seal, until it reached the through-bolt connections and ran into the enclosure.

EOS suggests that UCO or WPY staff fill the hole with caulk during the shutter trough re-caulk project.

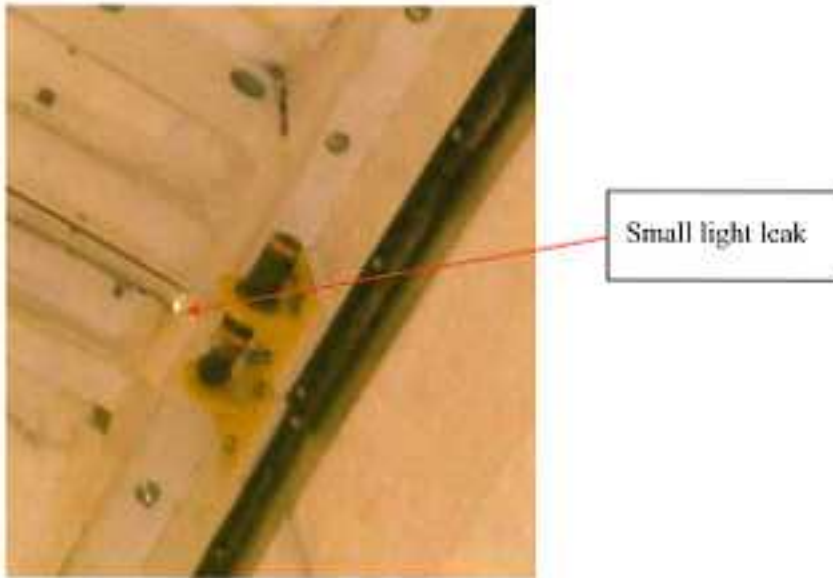
Figure 17 Shutter butt joint light leak

UCO-Lick identified a light leak, but no mention was made of a water leak at this point.

For water to ingress at this point, it would have to travel through a series of fibreglass overhangs, and be blown up-hill.

EOS response is that this claimed leak is not in fact an issue, as no evidence of water, or the ability for water to enter here exists. UCO-Lick can adapt the shutter if they wish to try and reduce the small amount of light leakage.

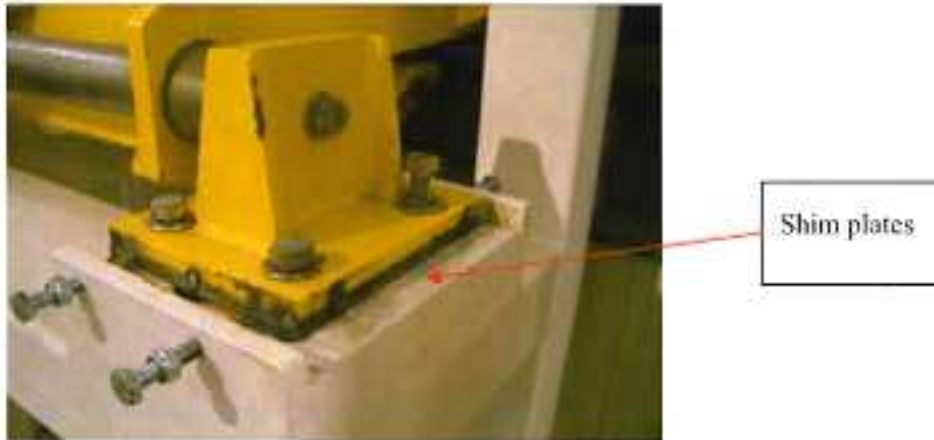
Figure 18 Azimuth drive assembly shimming

It was observed by UCO-Lick that both Azimuth drive wheels were not making 100% contact with the Azimuth ring beam.

UCO-Lick were also instructed to minimise operation of the azimuth until the rear (Front was completed by Jason) drive assembly was adequately shimmed.

Pinch rollers were also adjusted to enhance azimuth operation.

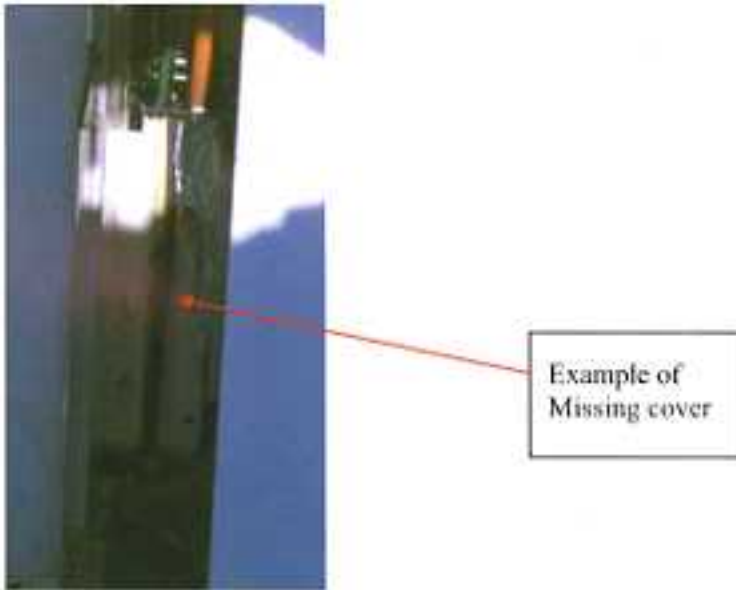
Figure 19 Snow melt cables

It was observed by Jason Chapman that the snow melt cables were in a dangerous state, missing mechanical protection in the shutter trough. The shutter cable chain could eventually wear through the insulation and the potential for electrical fault is high.

All cable covers were supplied on site. The particular cover missing would have to be trimmed in situation. WPY would have been responsible for this work as part of the enclosure build.

The Snow melt cable was still in good condition at the time of the inspection by Jason Chapman.

Example of
Missing cover

EOS will re-supply the missing cover. WPY should install the cover correctly during the trough re-caulk work.

UCO-Lick were instructed verbally not to operate the shutter system unless under extreme caution and at their own risk.

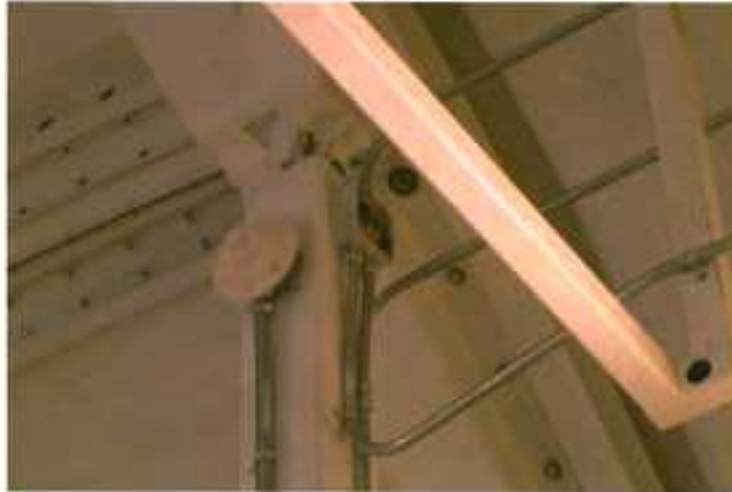
Figure 20 THUD box on Hanger

The upper THUD box on the observing space hanger is missing a lid. Although this lid was installed by EOS prior to leaving site, EOS will supply another lid for installation by UCO-Lick.

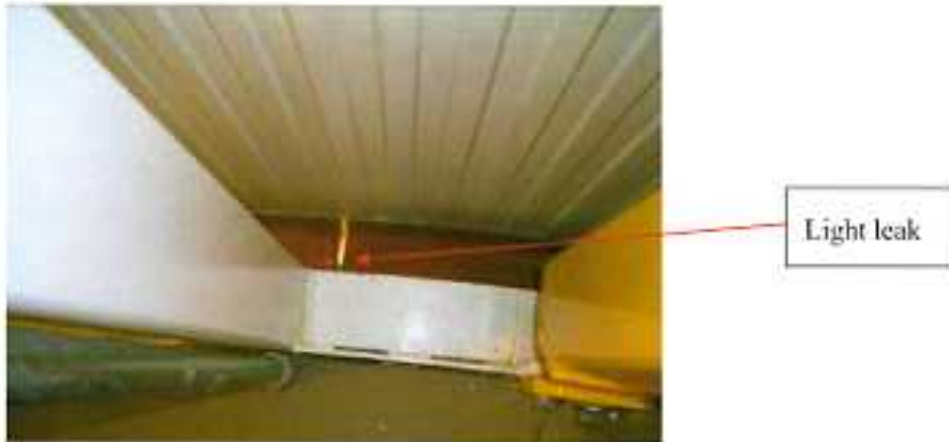
Light leaks were observed by UCO-Lick.

Figure 21 Ring Wall seal light leak

When the ring wall seal was installed, it appears the overlapping flaps were not installed to cover 90% of the gap.

Small rubber flaps should have been cut and installed by WPY during the enclosure build.

Jason Chapman found surplus silicone rubber on site and verbally instructed UCO-Lick on the correct procedure to cover the gaps.
