LICK RING WALL RECEIPT INSPECTION REPORT

1. LICK RING WALL RECEIPT INSPECTION

The initial ring wall receipt inspection was carried out on Wednesday 24/11/2004 with a follow up inspection on the 8/12/2004, at The Railways Workshops in Goulburn. A full survey of the ring beam, plus metrology of all finished parts was carried out by Mark Elphick and Jason Chapman on the 24/11/2004. Personnel present for the follow up inspection were Mark Elphick and Robert Paragalli. The principle contractor Ken Ainsworth was in attendance for both receipt inspections.

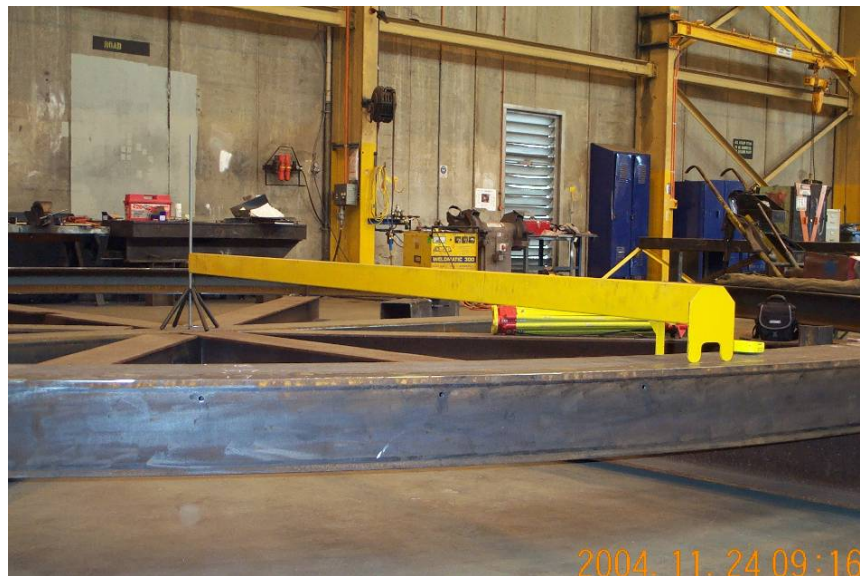
Figure 1-1 Trammel and ring beam

1. The ring beam was tested for circularity using an EOS supplied trammel and a set of digital verniers. The inside radius of the top flange of the UC was the dimension referred to for this inspection. Reference points were set up using each column attachment hole set. Where these holes straddled a joint between ring beam sections, two reference marks were set up, one either side of the joint, giving (15) points of reference. The ring beam circularity was slightly outside of the drawing specifications; however the Mt Stromlo Icestorm facility seems to have a much worse case ring beam and still performs its specified function. The Lick enclosure ring beam should be passed if the mapped circle is a better case than the Mt Stromlo ring beam. See the "Lick Ring Beam Survey Report

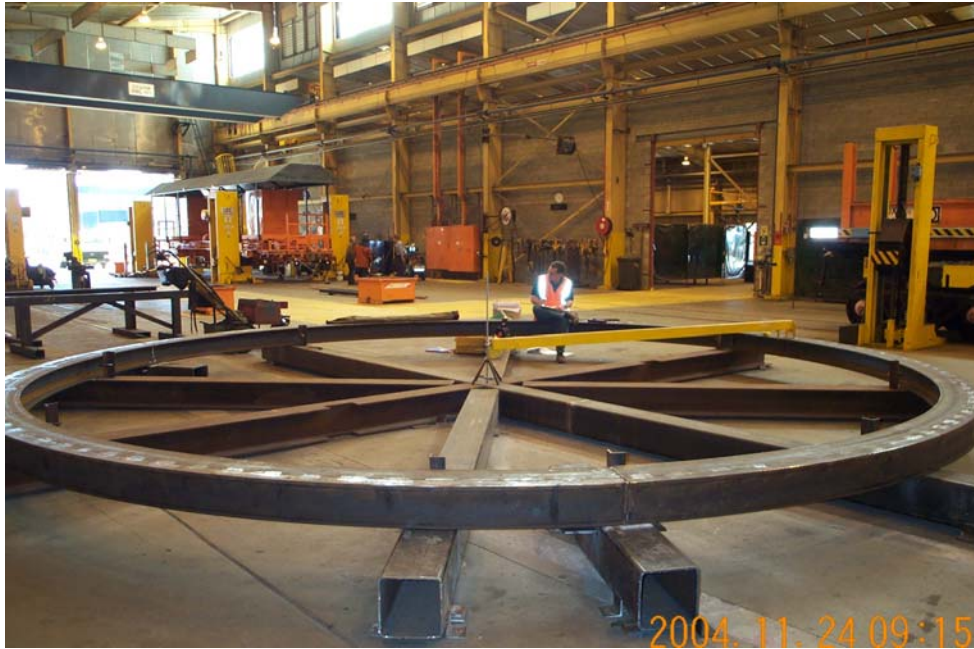
Figure 1-2 Ring beam

1. The overall flatness of the ring beam was measured using a precision level and staff. The levels were measured directly over the top of the vertical web of the UC, on the same radial line as the column attachment holes. Where these holes straddled a join between ring beam sections, two reference marks were set up, one either side of the join, as per the circularity test. The greatest variation in relative levels was 4mm (3) column spacings apart, within. See the "Lick Ring Beam Survey Report Doc "[Ring beam survey report.xls](#)"

2. The ring beam profile flatness (camber profile) was measured and referred to the perpendicularity tolerance on document MDD03029. Technically this tolerance included the channel welded to the back of the rolled UC. As the azimuth drive wheels and azimuth support wheels do not interface with the channel, this was discounted when calculating the perpendicularity of the ring beam. The levelling references were as per the overall flatness check plus points 20mm inside the OD and ID of the UC. A level was also taken at the centre of the UC upper flange at the corresponding reference points (related to the column attachment holes). "[Ring beam survey report.xls](#)"

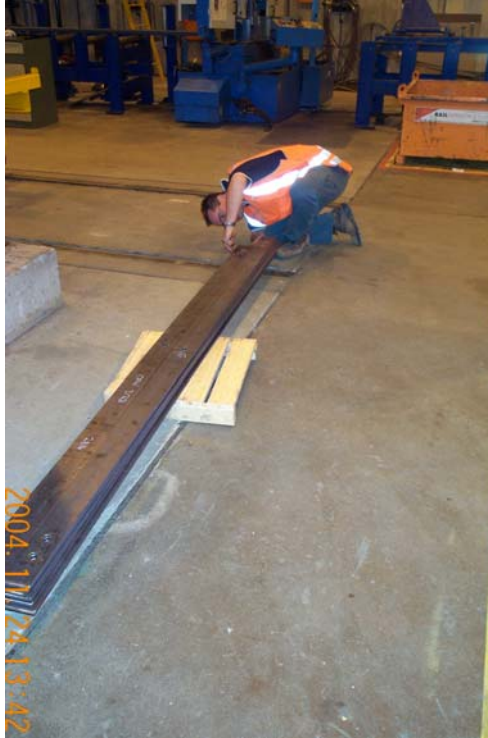
Figure 1-3 Diagonal Braces

Quantity 20-all dimensions within specifications outlined in drawing MDD 03128.

The fastener holes require de-burring.

All sections have been de-burred. Dimensions are all within specifications-see first RI.

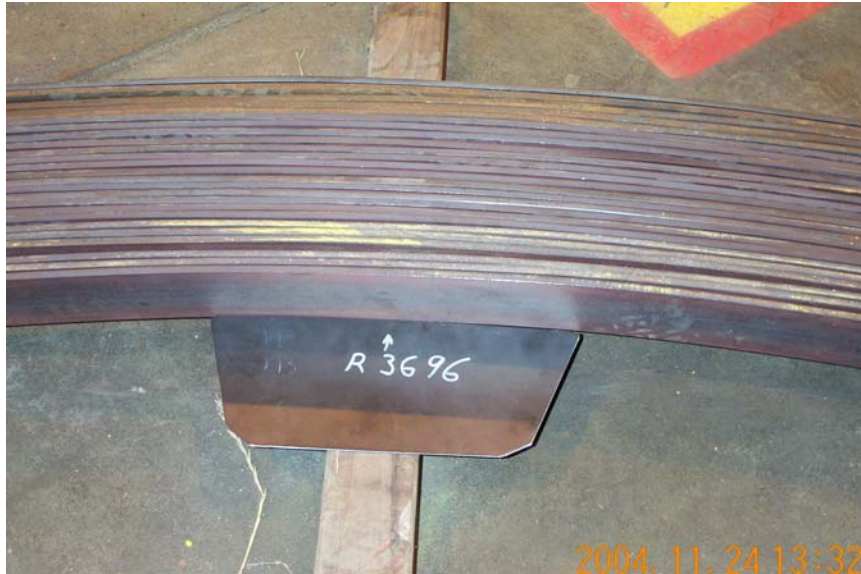
Figure 1-4 Horizontal inner girts

Quantity 25- all dimensions within specifications outlined in drawing MDD 03091.
Chamfers are 25mm not 30mm-25mm was adopted to avoid sharp edges on steel.

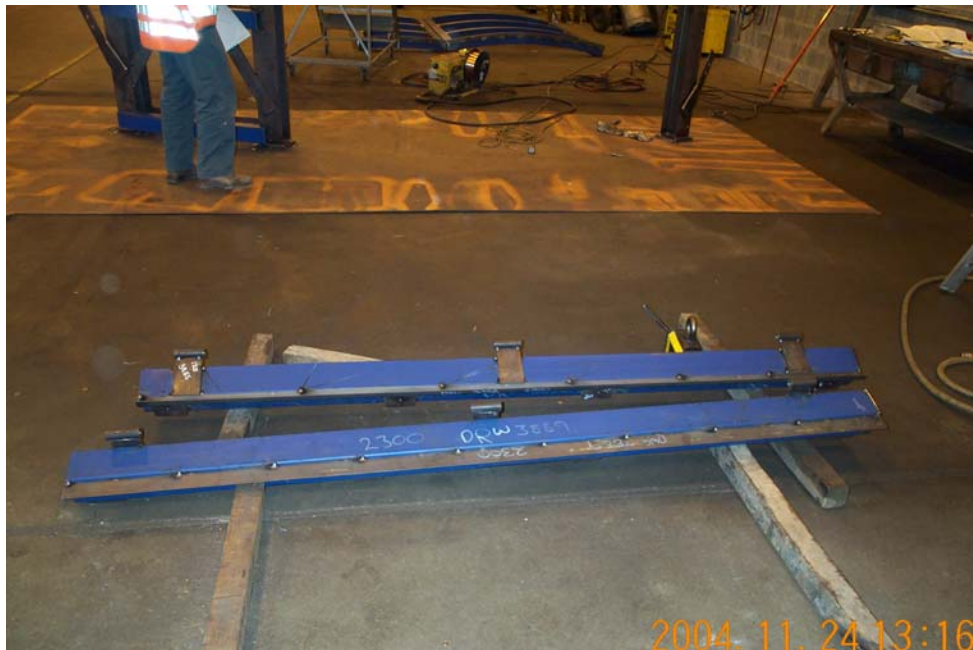
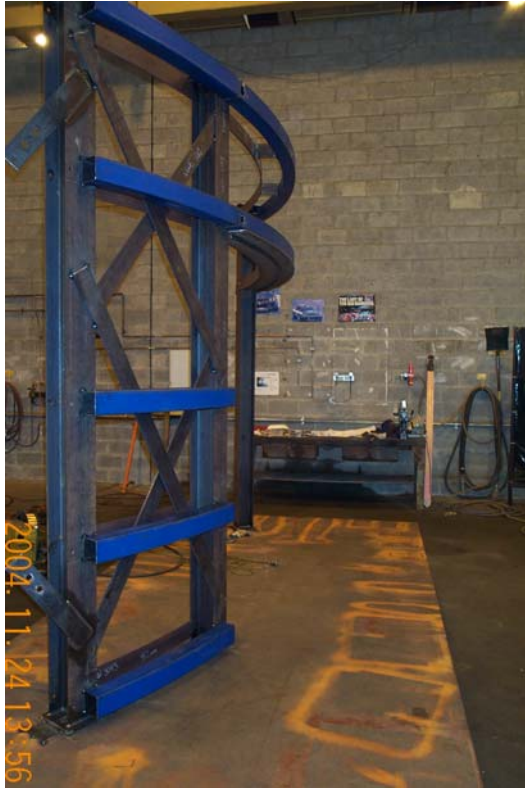
The door assembly and ring wall column double were incomplete and will be revisited when the second RI is scheduled. See Chapter 2

Figure 1-5 Equipment door columns

Figure 1-6 Incomplete equipment door

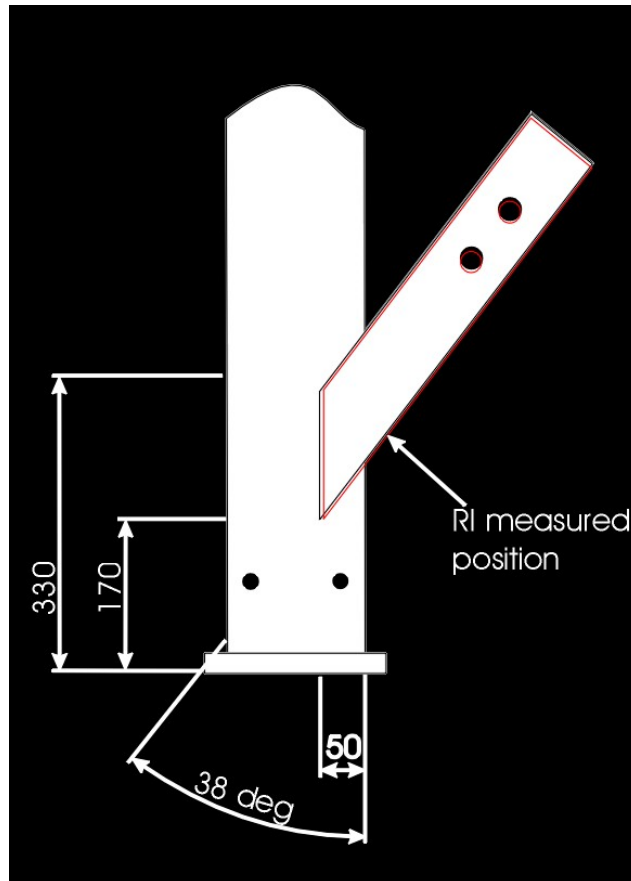
Figure 1-7 Misaligned cross brace support tabs

A problem was encountered with the ring wall column balcony supports. The attachment cross brace support plates were shortened by 5mm to accommodate the weld fillet between the cross brace support plate and the balcony support plate, resulting in the tab being misaligned by 6mm vertically.

The tabs will not require repositioning as the problem can be addressed during construction. However it does highlight the problems that can be created if verification is not obtained prior to altering fabricated parts.

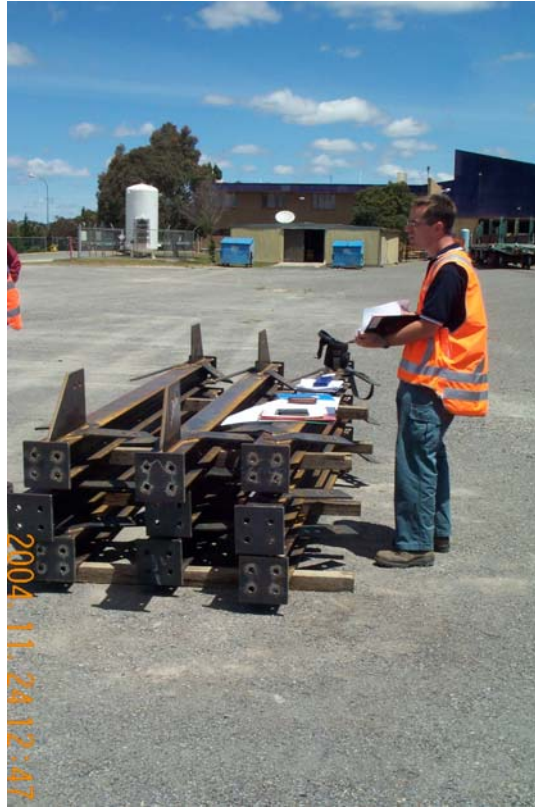
Figure 1-8 Ring beam columns

The nine available ring beam columns were checked all ring wall Type 1 dimensions are as per drawing MDD 03087.

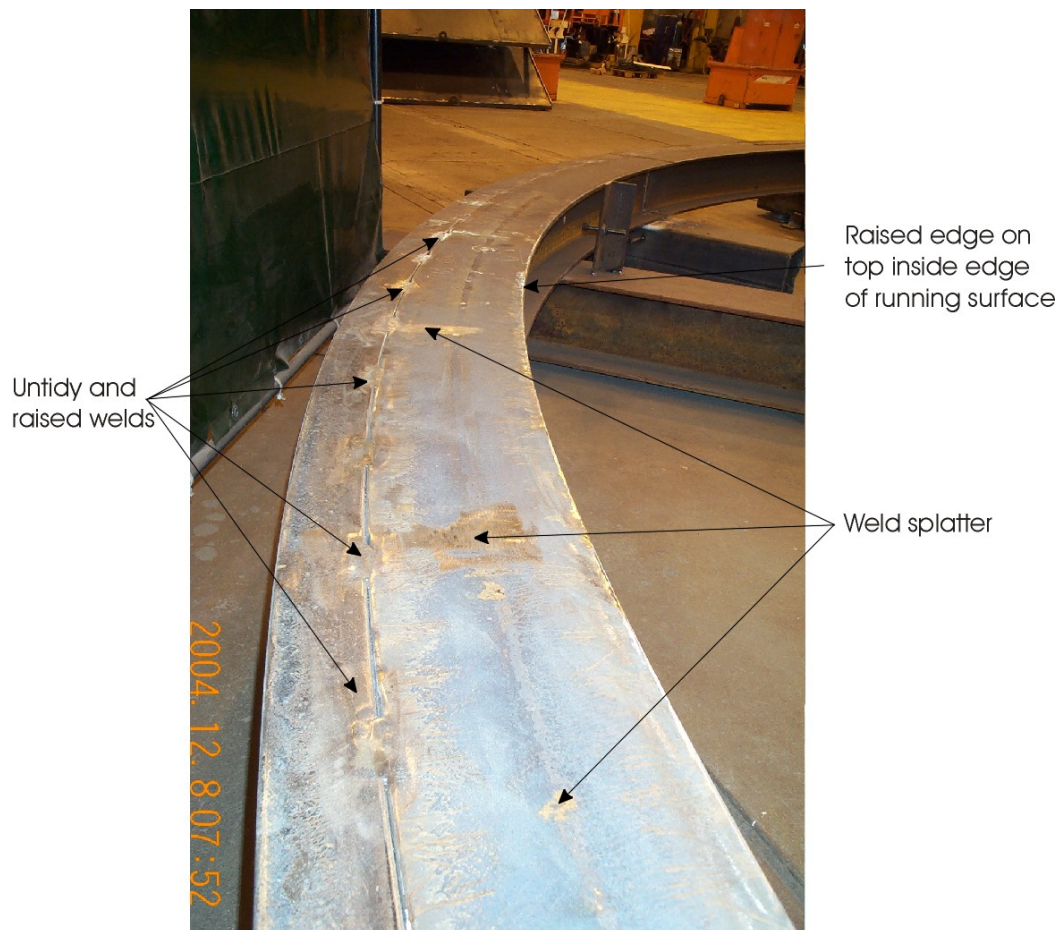
Figure 2-1 Ring beam RI issues addressed

1. Weld spatter removed from ring beam running surface.
2. Raised and untidy welds between UC and channel ground down.
3. Raised lip on the inside of the ring beam running surface ground flush with ring beam running surface.

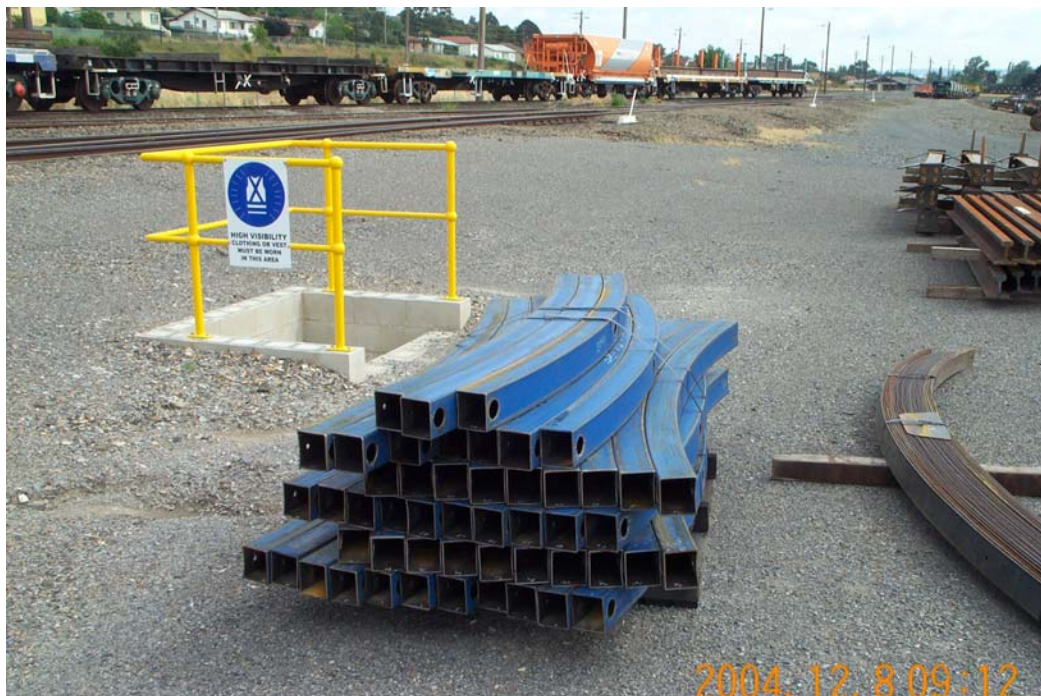
Figure 2-2 Horizontal outer girts

There are 44 horizontal outer girts and 6 horizontal outer girts type 2 required. All girts inspected were as per drawing MDD 03090, none were of type 2 MDD 07990.

This issue has now been addressed six of the normal girts had 10mm cut from each end. There are now 44 horizontal outer girts and 6 outer girts of type 2 – 50 girts in total.

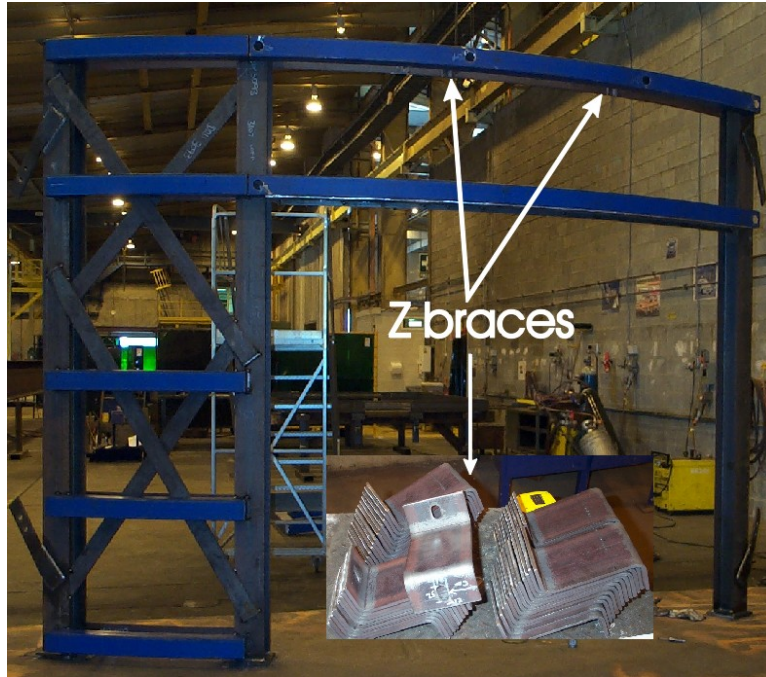
Figure 2-3 Z braces

Initial RI there was two Z braces unaccounted for. The two missing Z braces are being used in the erected ring wall section that houses the equipment door – 52 in total.

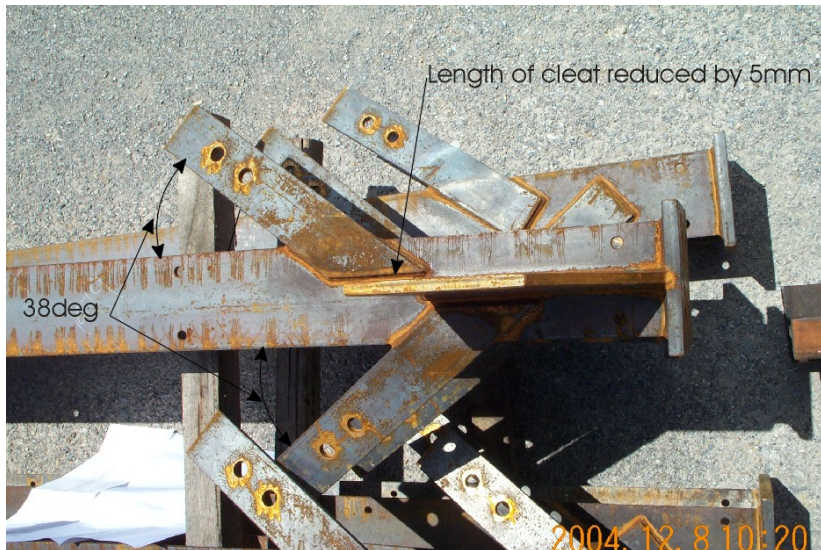
Figure 2-4 Balcony support columns

The length of the cleat was reduced by 5mm to accommodate weld fillet, all other dimensions are as specified in MDD 07967. See section 1.5.

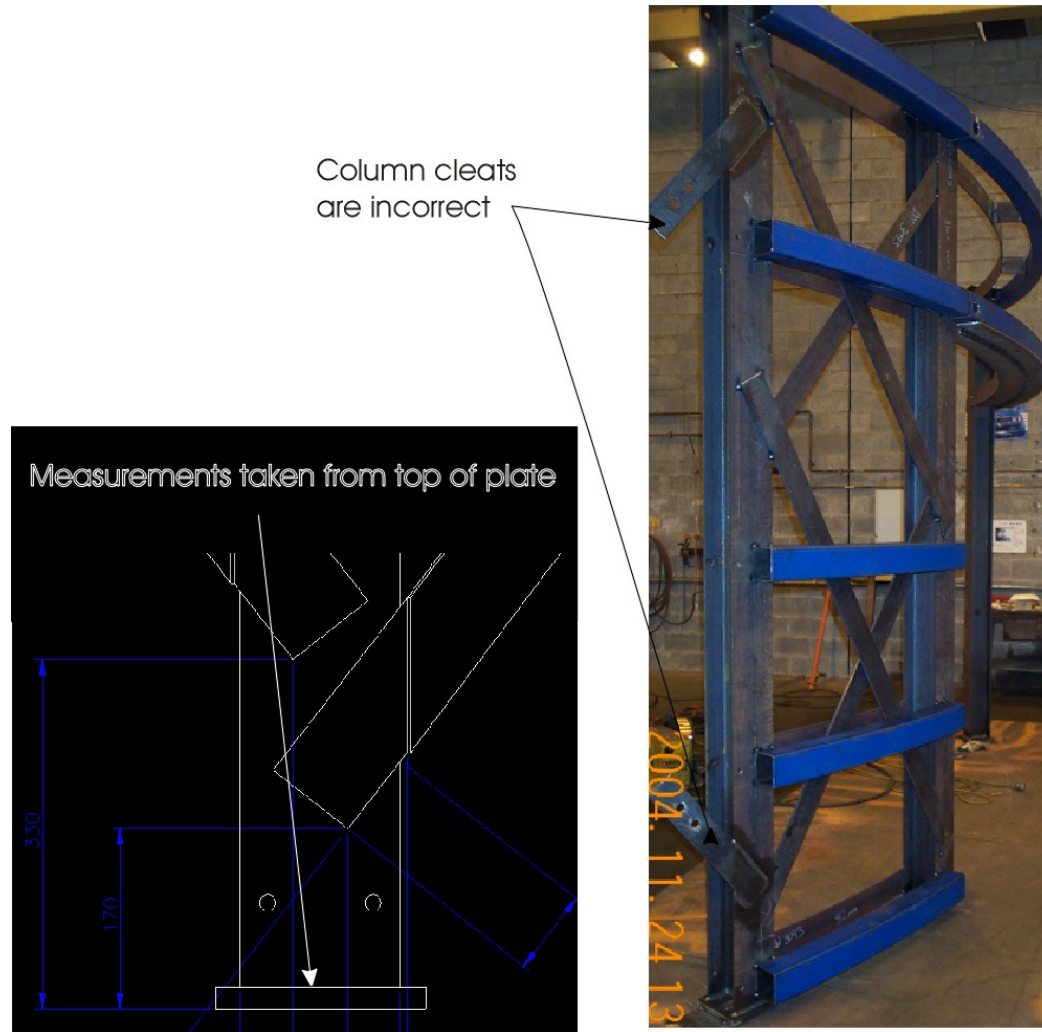
Figure 2-6 Ring wall double column

The column cross brace support tabs were the only problem on the double column. The measurements were taken from the inside of the column base plate and should have been measured from the outside of the plate (See Figure 2-6). Column cross brace support tabs need to be removed and re-welded in the correct position.

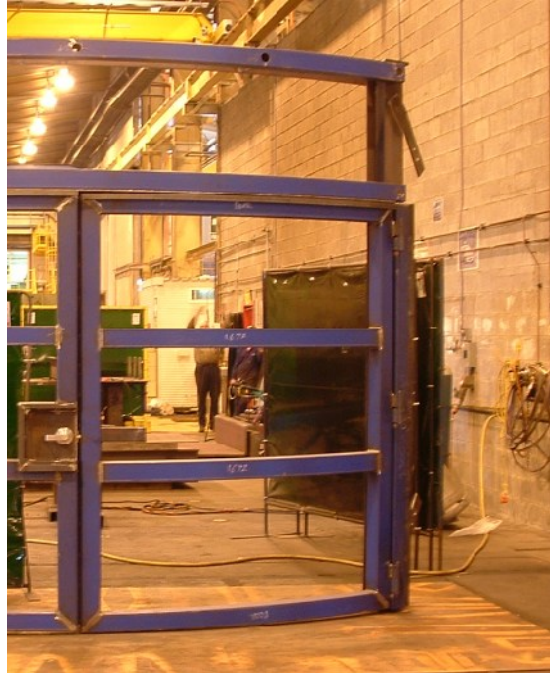
Figure 2-7 Single column

The column cross brace support tabs were the only problem on the single column. The measurements were taken from the inside of the column base plate and should have been measured from the outside of the plate (See figures 2-6 and 2-7). Column cross brace support tabs need to be removed and re-welded in the correct position. All other dimensions are as per specifications in drawing MDD 03348.

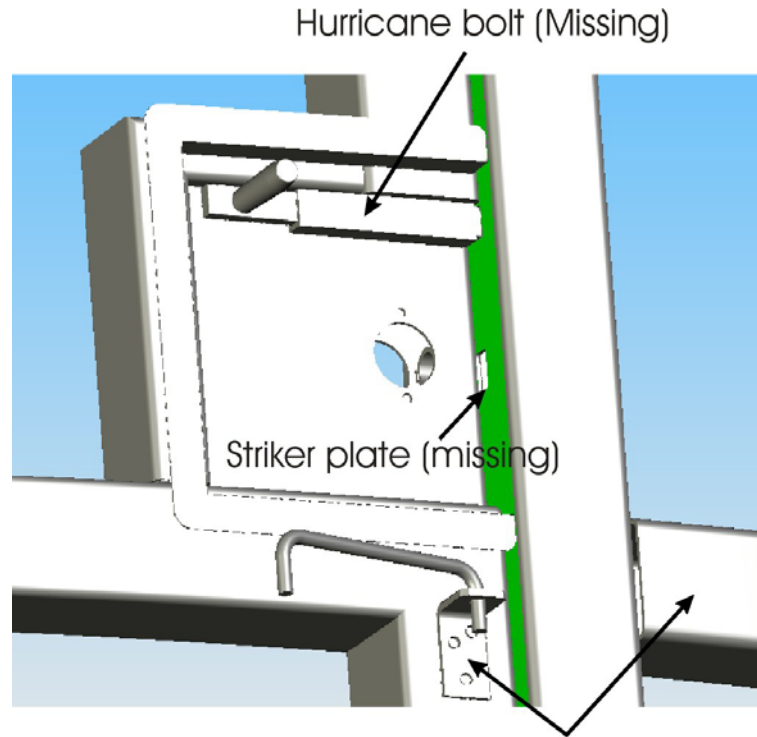
- Missing striker plate.
- Hurricane bolt-not yet manufactured.

Door retaining bracket and bolt (missing 2 of)
Figure 2-8 Door locking mechanism

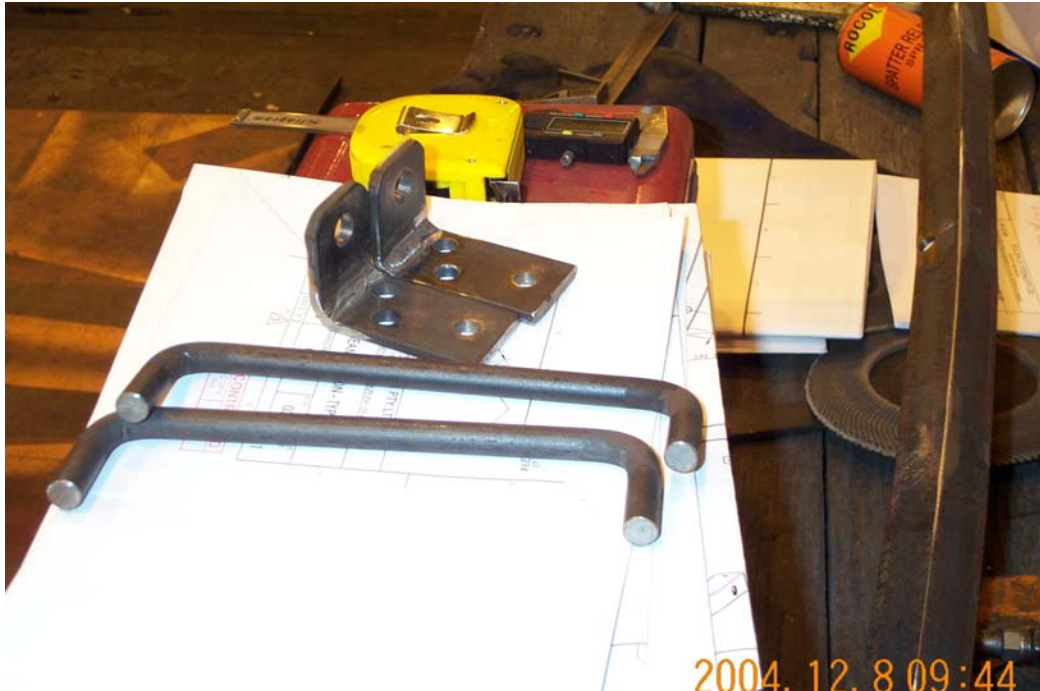
Figure 2-9 Retaining brackets and bolts

- Door retaining brackets and bolts for double and single door. Only two brackets had been fabricated however both bolts were available. Manufacture two more brackets and install the brackets on the double and single door (See figure 2-9)

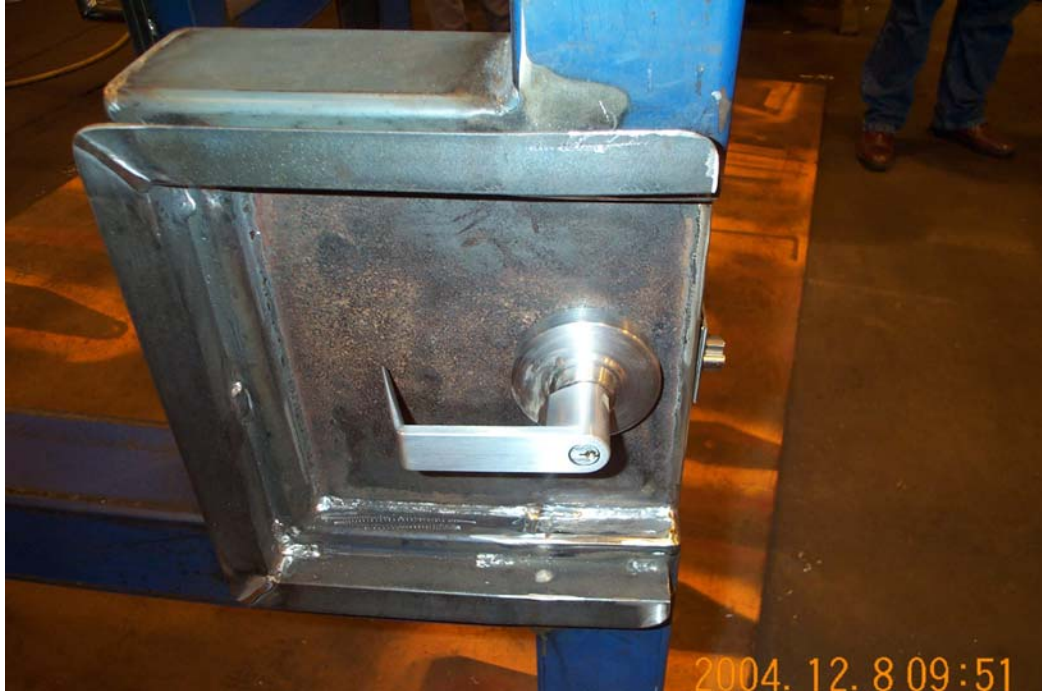
- The steel plate housing the door lock requires the welds to be grinded back. Many of the welds are uneven and proud (See figure 2-10).

Figure 2-10 Untidy welds on door lock housing plate
