UCCO/Lick APF

IceStorm Enclosure (Series 2)

Lick APF Site Inspection Report

6 June 2007

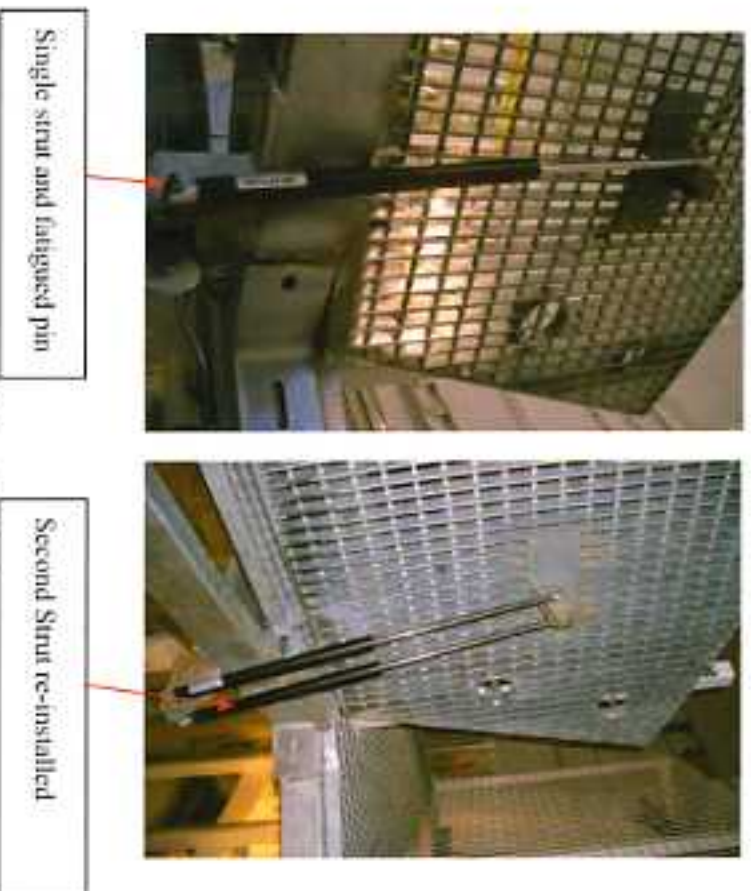
Figure 3.1.3 Hatch struts.

UCCO-Lick indicated that the level 3 floor hatch mounts are not adequate and safe. An attempt was made by EOS to improve the use of the hatch by removing a gas strut from each hatch section during 2006.

It is agreed this is not an adequate fix and potential for serious injury increased, due to insufficient force applied by the single strut preventing the hatch from falling. It has also meant that strut pins may have fatigued as they are "working" twice as hard.

A site inspection prompted Jason Chapman to advise UCCO-Lick to lock the hatches in a safe position until appropriate remedy is applied. The second gas strut was re-installed to the heaviest hatch piece and the hatch became workable.

The position of the struts is determined by the geometry of the hatch.

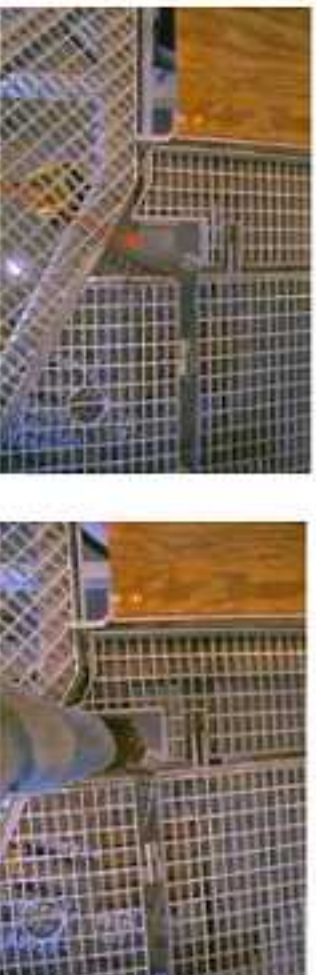
UCCO-Lick identified a void in the level 3 floor adjacent to the hatch. The void has the potential to be a trip hazard.

During assembly of the enclosure, EOS provided an infill piece to fill the void, which was caused by hatch modifications. The piece was small and was not located on site when Jason Chapman inspected the enclosure in May 2007.

Figure 4 Void in floor. EOS are asking UCCO to fill.

UCCO should find or make and install this part to eliminate the trip hazard.

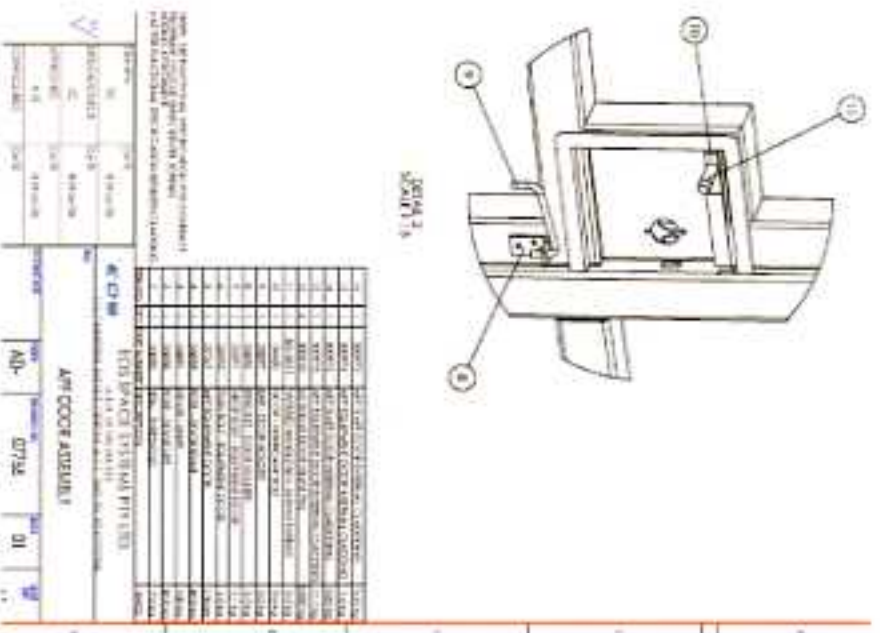
UCCO-Lick claimed a safety hazard was imposed by the exterior deadbolt system on the staff entry door. The claim was made that someone could be trapped inside the enclosure if the bolt was utilised. UCCO-Lick appeared to be under the impression the deadbolt was temporary.

The deadbolt existed as a precautionary lock during extreme survival conditions, to avoid the door latch being the only part preventing the shaft door from being sucked open. The deadbolt has always been part of an IceStorm design, it is present at the Mt Stromlo facility and appeared on design review models.

Figure 5 Excerpt from door drawing – Calls out dead bolt as “Door Hurricane Bolt”

EOS does not consider this as a design flaw or safety risk and proposes no further action is required. However, for the abundance of caution, if UCO-Lick deem this to be an unacceptable risk, then we propose to cut off the deadbolt tang to render the deadbolt inoperable.

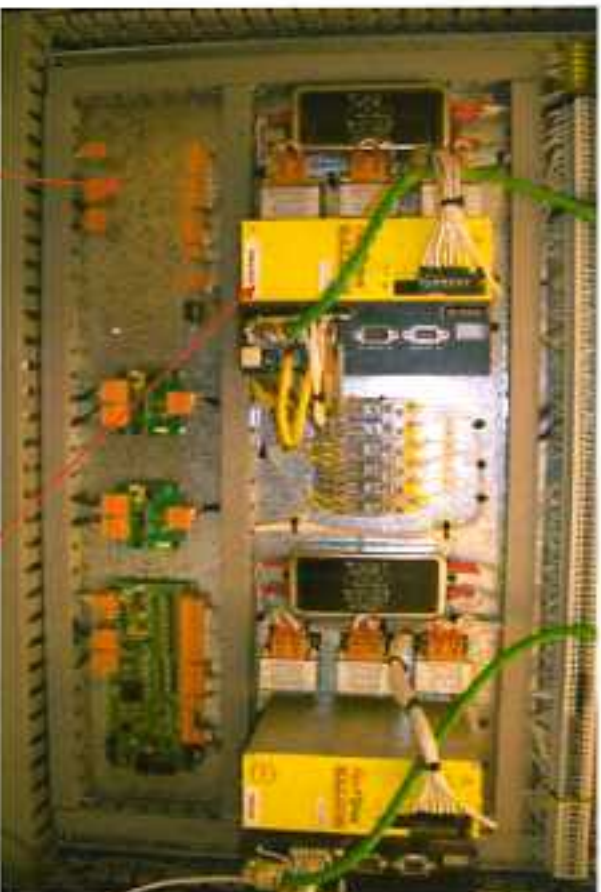
Figure 6 Shutter control panel

UCCO tried to operate the front shutter after a period of high rainfall. The shutter would not operate and a preliminary investigation showed potential damage to a printed circuit board directly linked to front shutter operation.

The printed circuit board was replaced on site by Jason Chapman and the replacement proved to have communications with the appropriate parts of the control systems, however the shutter was still not operational.

Further investigation by Jason Chapman and Steve Vogt indicated that the front shutter controller / amplifier was not communicating with the rest of the control systems. After a phone conversation with the EOS electrical group the decision was made to remove the amplifier and return it to Australia for assessment.

The control cabinet has obvious signs of water ingress, which seems the most likely cause of shutter parts malfunction or failure. The water has apparently made its way into the control cabinet from upper levels of the enclosure. During installation, EOS installed expansion foam on the top of the cabinet to control moisture ingress (water and humidity) to the control cabinets. On inspection this was no longer present.

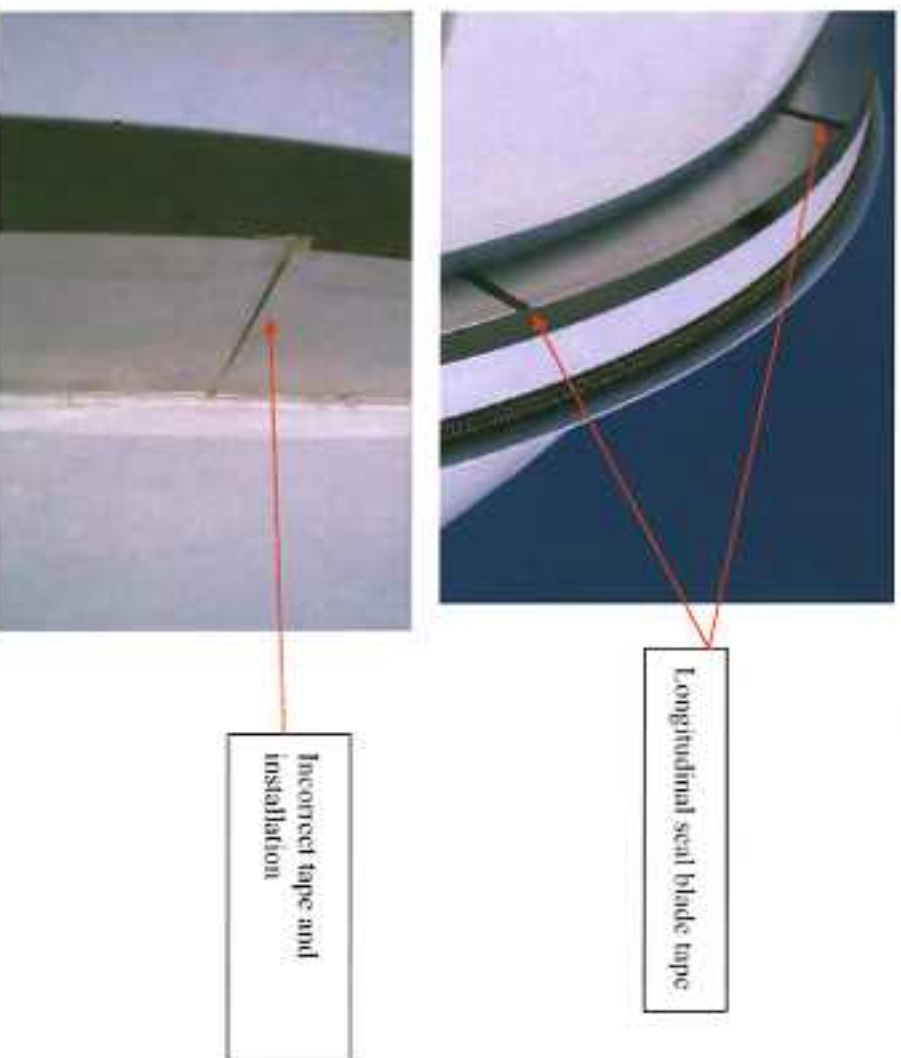
UCCO noted that a tape installed on the longitudinal seal blade was falling away.

Further investigation by Jason Chapman and Matt Radovan showed the tape on the seal blade was not the correct tape specified by EOS. It was also noted that it was installed in incorrect positions and was probably installed on stainless steel blades that were not cleaned sufficiently prior to installation of the tape.

Figure 7 Longitudinal seal blade tape, preventing seal flap snags on blade ends.

Temporary tape had been installed during shutter frame alignment. The final to-be-installed tape was issued and was to be re-installed by W/PY after shutter alignment work was complete.

New tape will have to be installed after the trough re-caulking procedure has been completed. When re-installing the seal blades, they will be required to properly install the correct tape. EOS can provide instruction on this.

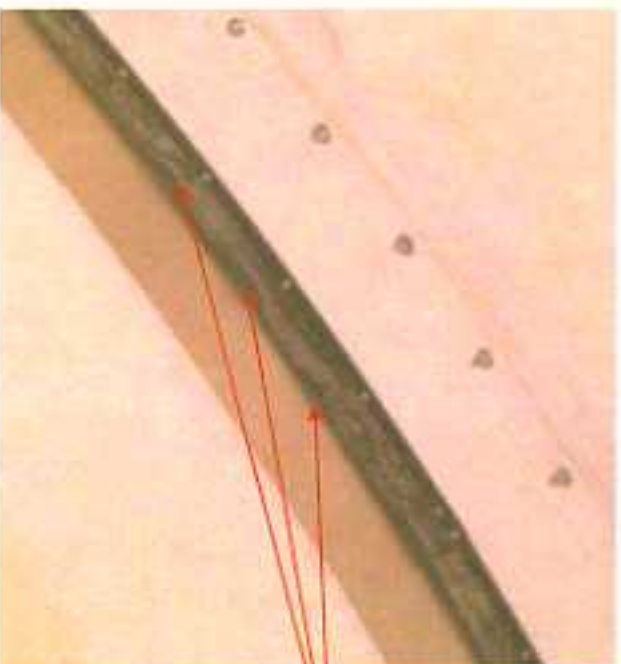
Figure 8 Longitudinal seal flaps.

LICO-Lick has stated that the shutter longitudinal seals flaps are not sealing appropriately due to wrinkling.

Wavy / wrinkled longitudinal seal flaps. There is a potential to cut and tape to reduce the wrinkling effect.

These longitudinal seal flaps are installed to prevent significant light leaks and to minimize air flow between the exterior atmosphere and the enclosure interior. No light leaks were observable along these seal flaps. It is not easily determined if the seal flaps would improve air leakage significantly if they had 100% contact along their length.

As no moisture is infiltrating at these points EOS has determined the seal positions and function as acceptable, and replacement of the seals is not necessary.

At UCO-Lick's discretion, the seal flaps may be relieved to reduce wrinkling, with cutting then taping (with UHMWPE tape) between joints by UCO or WPY during the re-caulking project.

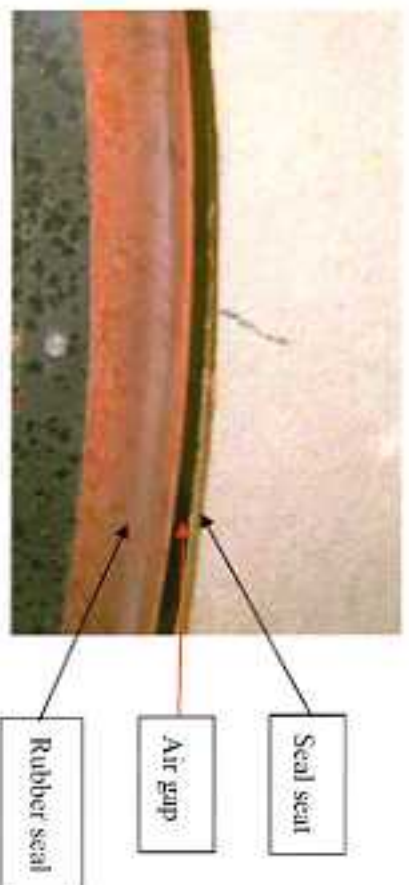
UCO-Lick observed a source of light leak from Level 1 to Level 2 during night hours, when Level 1 lights are switched on and the observing space is in darkness. The leak was traced to the seal that runs around the telescope base.

It appeared that there is a significant gap were the silicone rubber seal flap should run on a stainless steel pier seal seat.

Figure 9. Air gap present in pier seal.

The problem appears to stem from straight strips of rubber being bent on a tight radius to form the seal flap. The radius is seemingly too tight and the rubber folds back on itself without touching the seal seat.

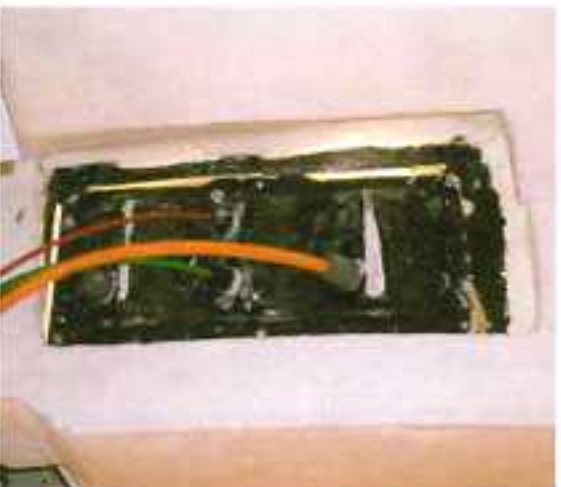
UCCO-Lick expressed dissatisfaction with the installation method of the shutter cables entry bulkhead, located on the inside of the troughs. There is no evidence of seal gaskets and 2/3rds of the attachment studs are missing nuts.

This was observed as being a valid assessment by Jason Chapman. Light leaks were prevalent around the bulkhead.

Light leak showing no seal

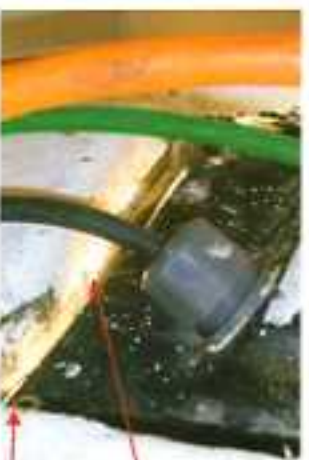
Missing fasteners

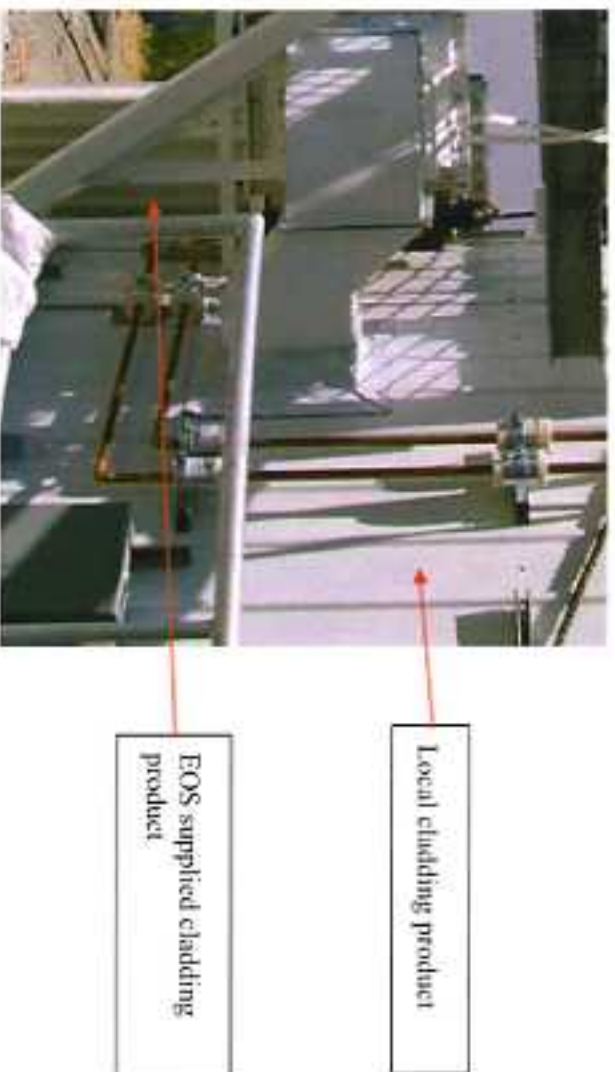
UCCO-Lick noted that during the assembly there were problems with steel ring wall cladding supply. Locally sourced cladding was required to finish the enclosure.

EOS does not consider the cladding profile difference to be a function, design or other issue and in fact enhances safety as it acts as a tactile indicator of reaching the door when highs are extinguished in the enclosure.

The cladding on the door has been sealed with closed cell foam that conforms to the EOS supplied cladding profile. The advantages of keeping the supplied cladding profile outweigh any visual effect from replacing it.

Figure 11 Different cladding on the entrance door and ring wall.

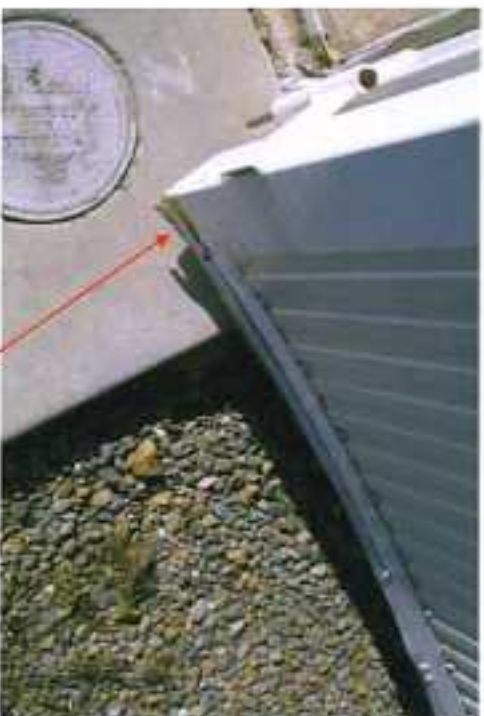
Figure 12 Entrance door weather seal

UCC-Lick pointed out a claimed deficiency in weather proofing the front entrance door. The claim was that seal material around the door jam is not sticking and the seal was inefficient.

The seal design is based on compression of closed cell foam between the door frame and the door jam or weather strips.

New closed cell seal tape can be provided and re-installed on clean steel door jams if required by UCO-Lick.

Seal style design will not change if no proof of normal weather conditions (wind blown rain other than extreme unusual force winds) causing leaks around the door can be demonstrated or recorded. If normal, as expected weather, can not infiltrate the entrance door seals the seal is regarded by EOS as fit for purpose.

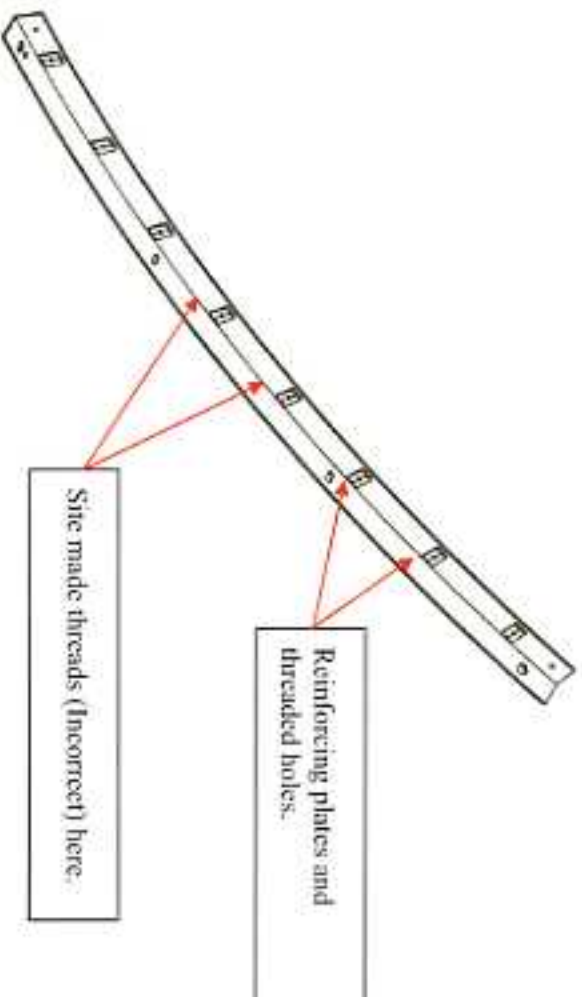
UCO-Lick claimed that an EOS representative, Mark Elphick, installed the flares in this manner. Ultimately WPY ought to have installed these parts.

Figure 13 Shutter rail - Shutter flares installed to these

UCCO-Lick would like assurances that the incorrect installation still meets survival conditions.

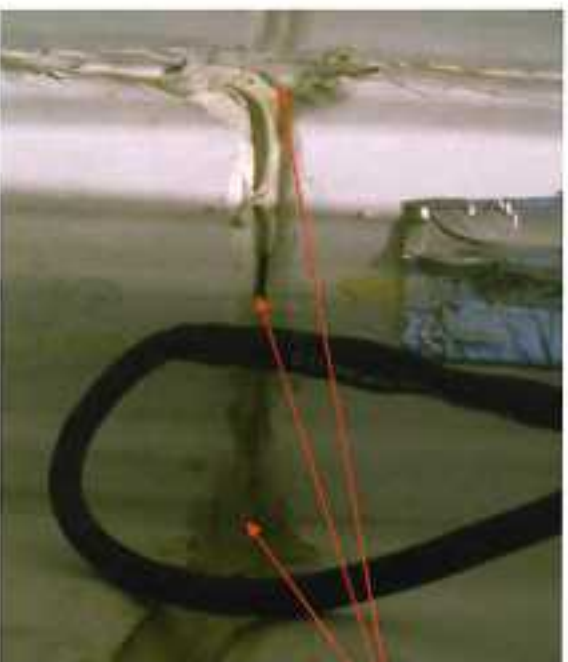
Figure 14 General example of trough sealing quality

Large pockets and gaps were easily distinguishable in most of the joints reviewed. All of these flaws would cause serious leaks, especially as the troughs act as a gutter during periods of precipitation. High flows of water would be prevalent in these areas.

The joints were also inspected by WPY. Matt Beaver, the WPY foreman during assembly, agreed that the workmanship was extremely poor and that it would in fact be possible to seal the troughs.

Gap through to enclosure interior, general poor quality caulk attempt in the trough region

EOS will provide a procedure to re-caulk the enclosure infills and troughs, which will attempt to eliminate the need to remove the shutters from the enclosure.

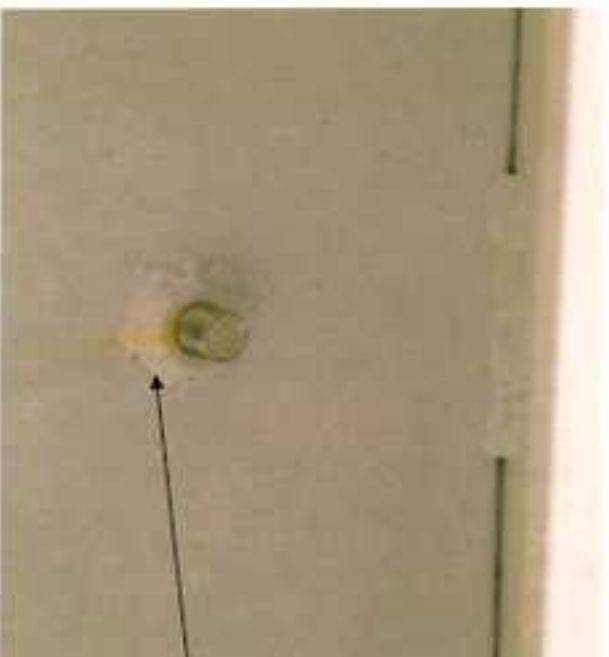
Figure 15 Skirt attachment screw

UCO-Lick incorrectly identified leaks as originating from the Vent Door Lower Rail Bolt Heads. Some slight discoloration is shown in the inside of the skirt attachment screws, inside the Azimuth support beam.

This discoloration is slight and Jason Chapman could not see any evidence of significant leaks, the discoloration may be caused by condensation after assembly, when the enclosure was still open to the elements. The position of the screws suggests it would be very difficult for water to make its way inside the enclosure from these points.

Slight staining around skirt attachment screw, inside Azimuth beam

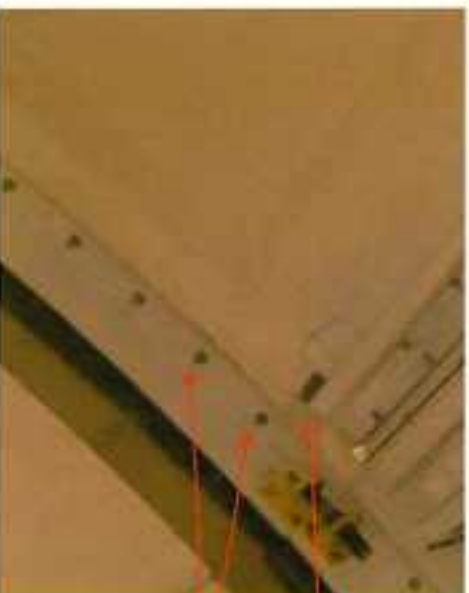
Figure 16 Shutter boot leak

UCCO-Lick found water dripping from 2 bolts on the upper right hand side of the front shutter, after a period of rain. An *assumption* was made that water had made its way into the enclosure via flare attachment points.

After investigation and suggestions by Jason to pour water on the shutter transverse gutter, the leak point was identified as a hole in the caulking, under the upper right hand side of the top transverse beam. Water channelled between an interior seal, until it reached the through-bolt connections and ran into the enclosure.

EOS suggests that UCCO or WPPY staff fill the hole with caulk during the shutter trough re-caulk project.

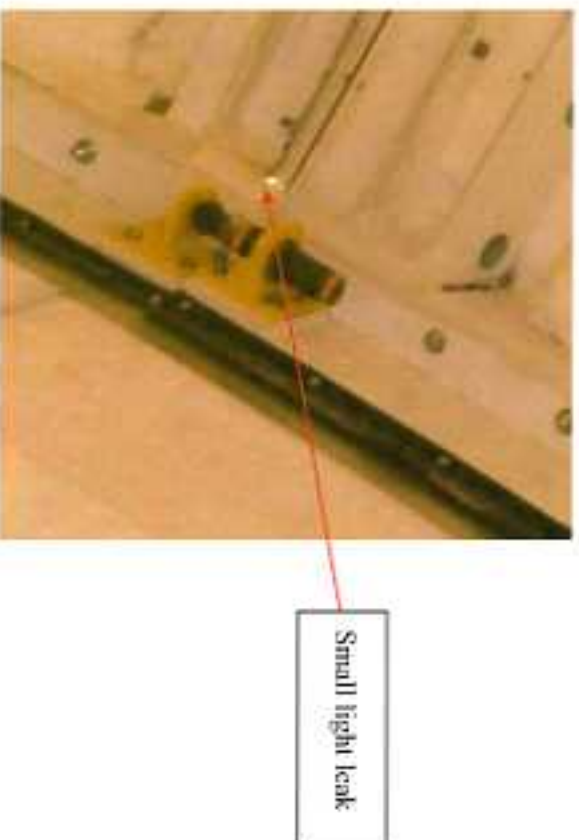
UCCO-Lick identified a light leak, but no mention was made of a water leak at this point.

EOS response is that this claimed leak is not in fact an issue, as no evidence of water, or the ability for water to enter here exists. UCCO-Lick can adapt the shutter if they wish to try and reduce the small amount of light leakage.

Leak originated outside around here

Leaks entered dome here

Figure 17 Shutter butt joint light leak

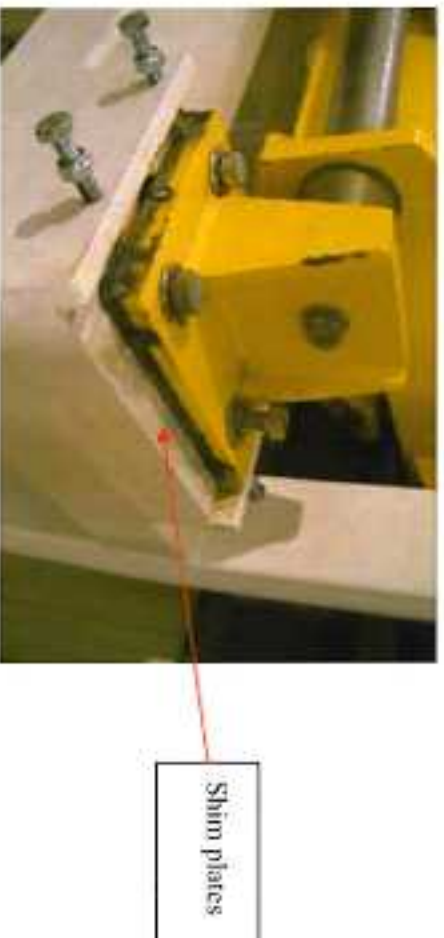
It was observed by UCO-Lick that both Azimuth drive wheels were not making 100% contact with the Azimuth ring beam.

Figure 18 Azimuth drive assembly shimming

UCO-Lick were also instructed to minimise operation of the azimuth until the rear (Front was completed by Jason) drive assembly was adequately shimmed.

Pinch rollers were also adjusted to enhance azimuth operation.
