UCO/Lick APF

IceStorm Enclosure (Series 2)

Lick APF Site Inspection Report

6 June 2007

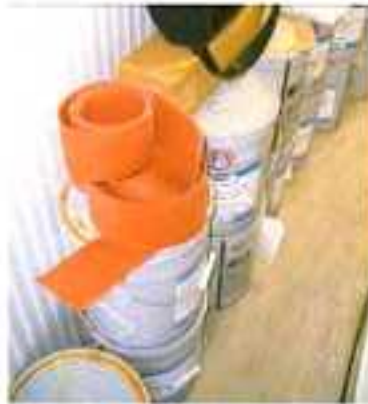
Small rubber flaps should have been cut and installed by WPY during the enclosure build.

Figure 22 Surplus silicone rubber

Jason Chapman found surplus silicone rubber on site and verbally instructed UCO-Lick on the correct procedure to cover the gaps.
