DRAWING NO. ASY-5671	REVISION REL-02
PROJECT CODE: LICK-51

TITLE: M3 MIRROR ASSEMBLY			
DRAWING NO. ASY-5671	STATUS Released	REVISION REL-02	SHEET SIZE A2
SCALE:1:2		SHEET 4 OF 5

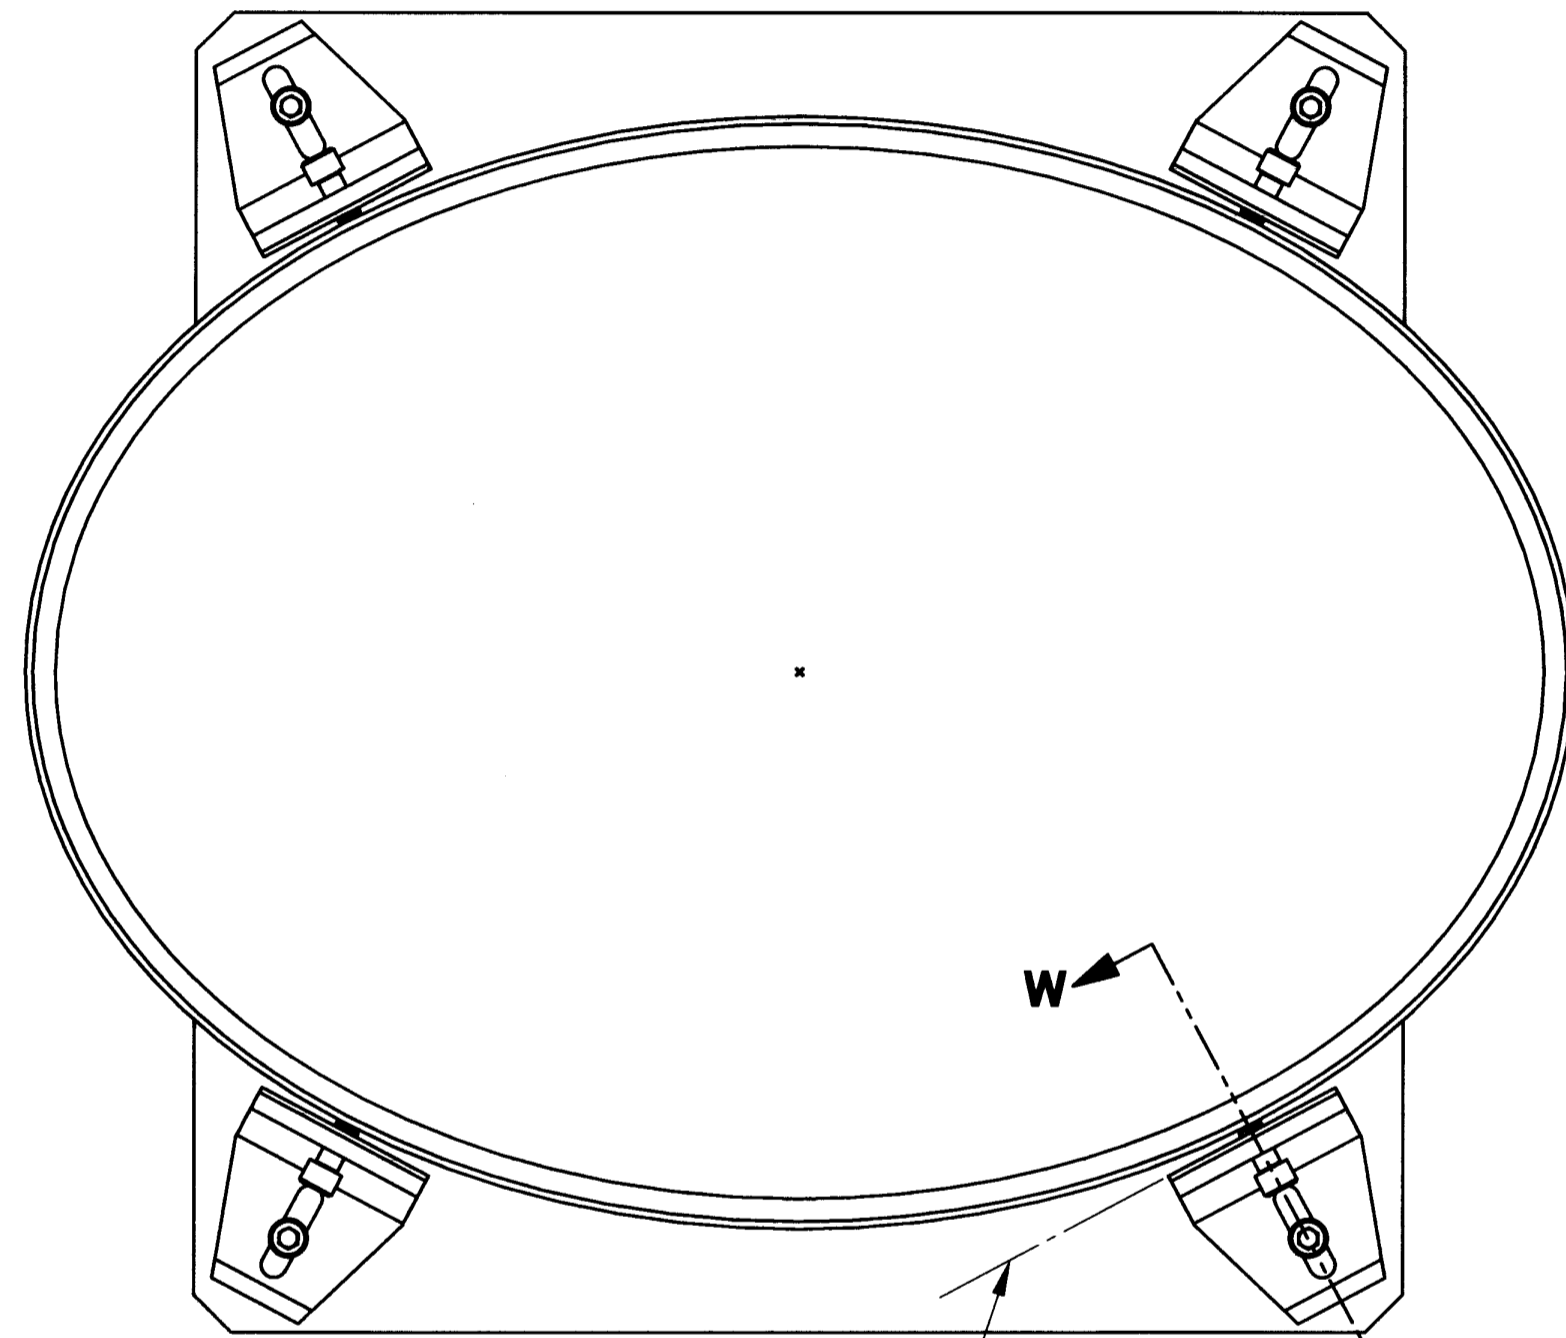
ALIGN THIS SURFACE OF THE ALIGNMENT BRACKET PARALLEL TO THE TANGENT OF THE MIRROR. ALLOW A 2 mm GAP BETWEEN THE MIRROR AND THE BRACKET. TIGHTLY FASTEN THE BRACKET TO THE FIXTURE PLATE BY SECURING THE TIE-DOWN SCREW. (DO NOT USE THREAD-LOCKING COMPOUND)

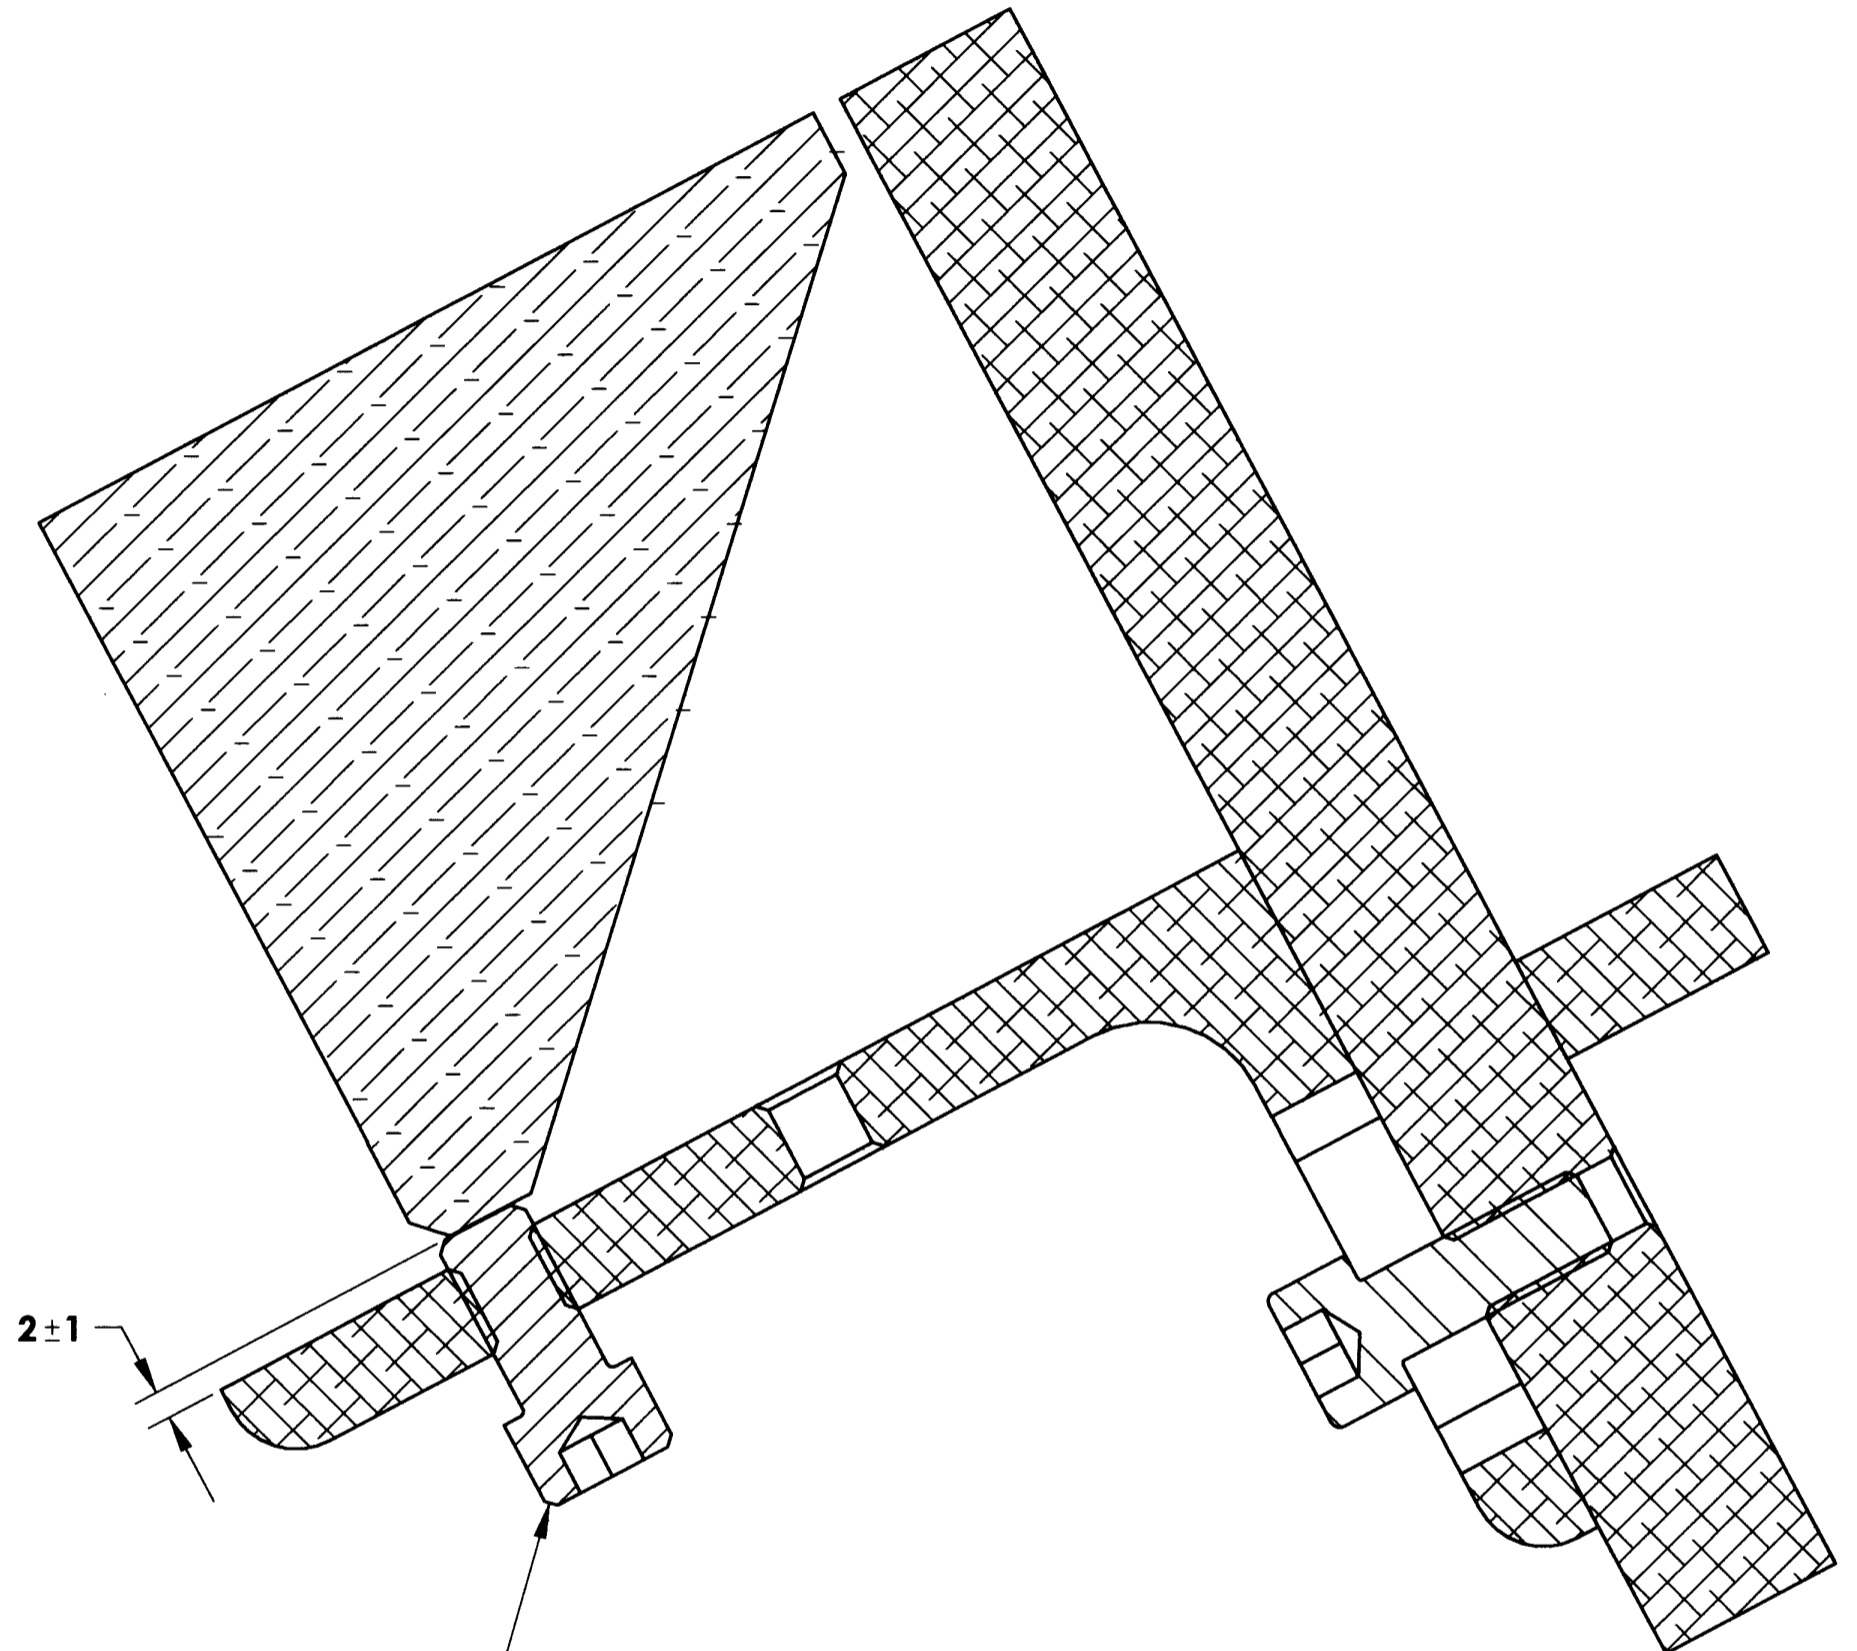
SECTION W-W
(SOME DETAILS NOT SHOWN FOR CLARITY)
SCALE 2 : 1

INSERT THE NYLON SCREW UNTIL IT JUST MAKES CONTACT WITH THE MIRROR. THIS WILL ALLOW THE MIRROR TO BE REMOVED AND REPLACED WITHIN ALLOWABLE LIMITS.
